United Nations  
Department for Humanitarian Affairs  
DHA Geneva

# Landslide *La Josefina* on the Paute River, Cuenca, Ecuador

## Report on Disaster Management (English Version of the Consultancy Report)

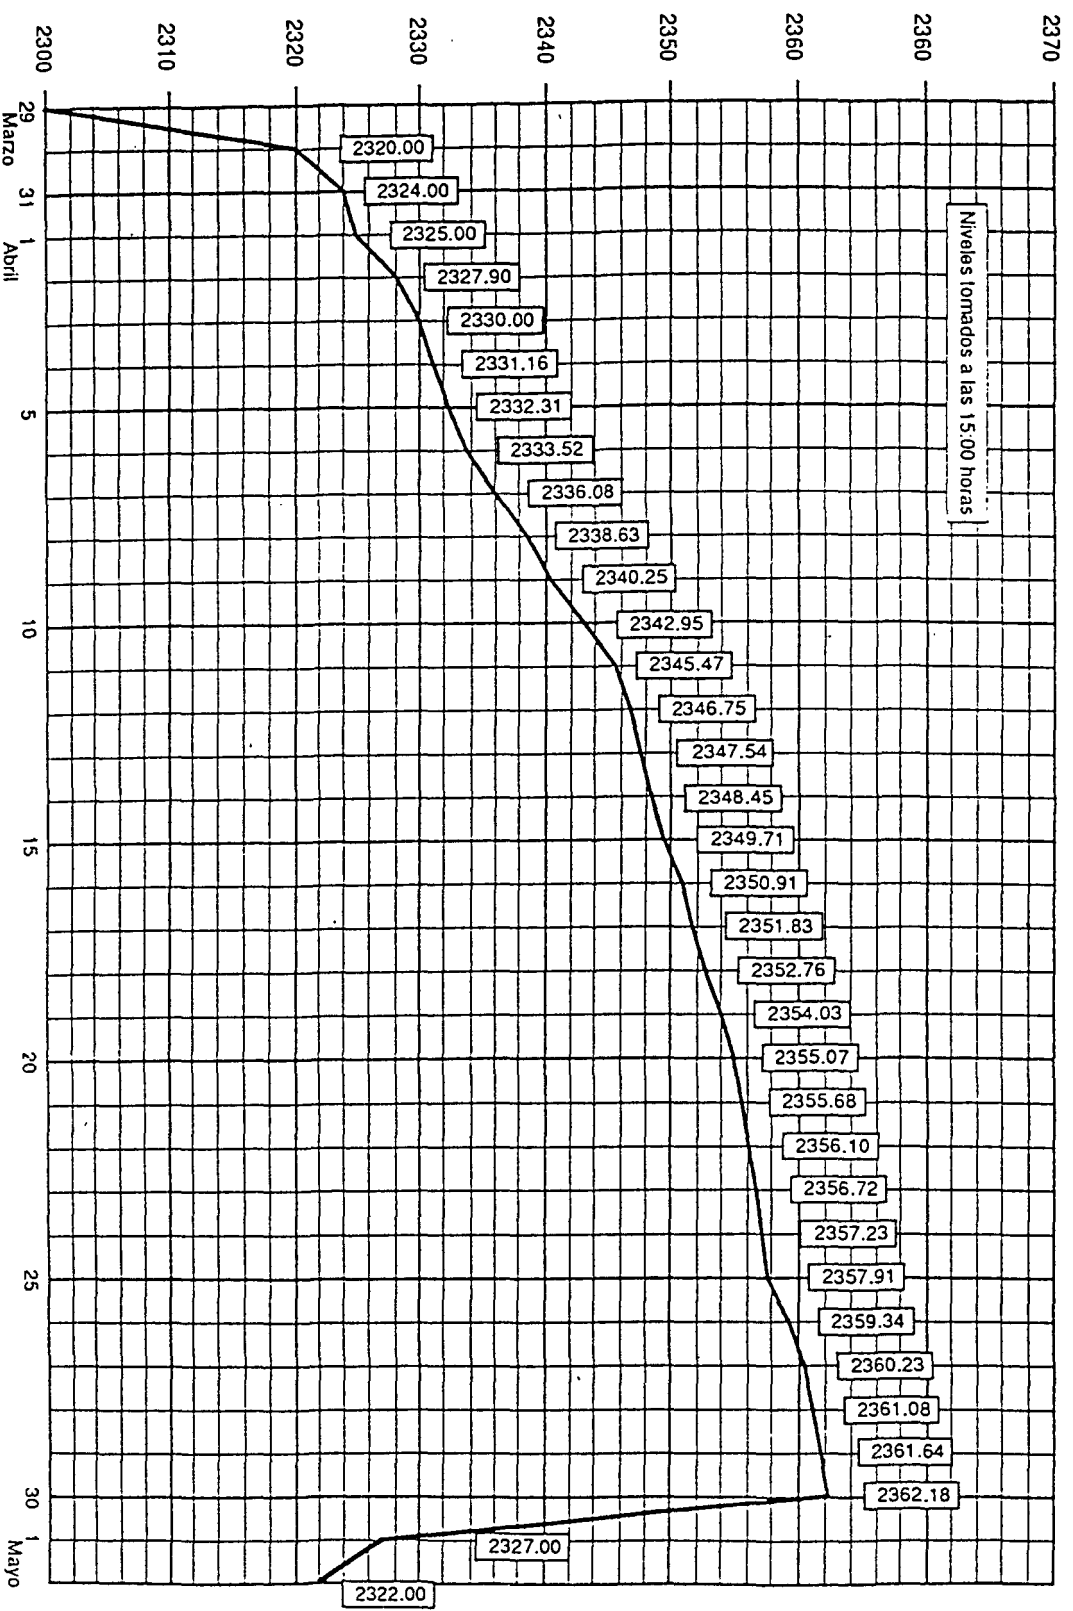
Figure 4: Water Levels in the La Josefina Reservoir

The daily variation in the level of the dammed-up water on the Paute ranged from a maximum of more than 3.00 m to a minimum of 0.50 m. The difference of level between the dammed-up water on the Paute and the Jadán also varied with time in relation to the amounts of water supplied by the River Jadán and infiltration from the dammed-up water on the Paute. The levels of the two water bodies were equalized on 18 April 1993, when the River Paute reached a level of 2,352.50 m above sea level, corresponding to the level of the embankment separating the two bodies of dammed-up water. The rise of water levels in the La Josefina Reservoir is shown in Figure 4.

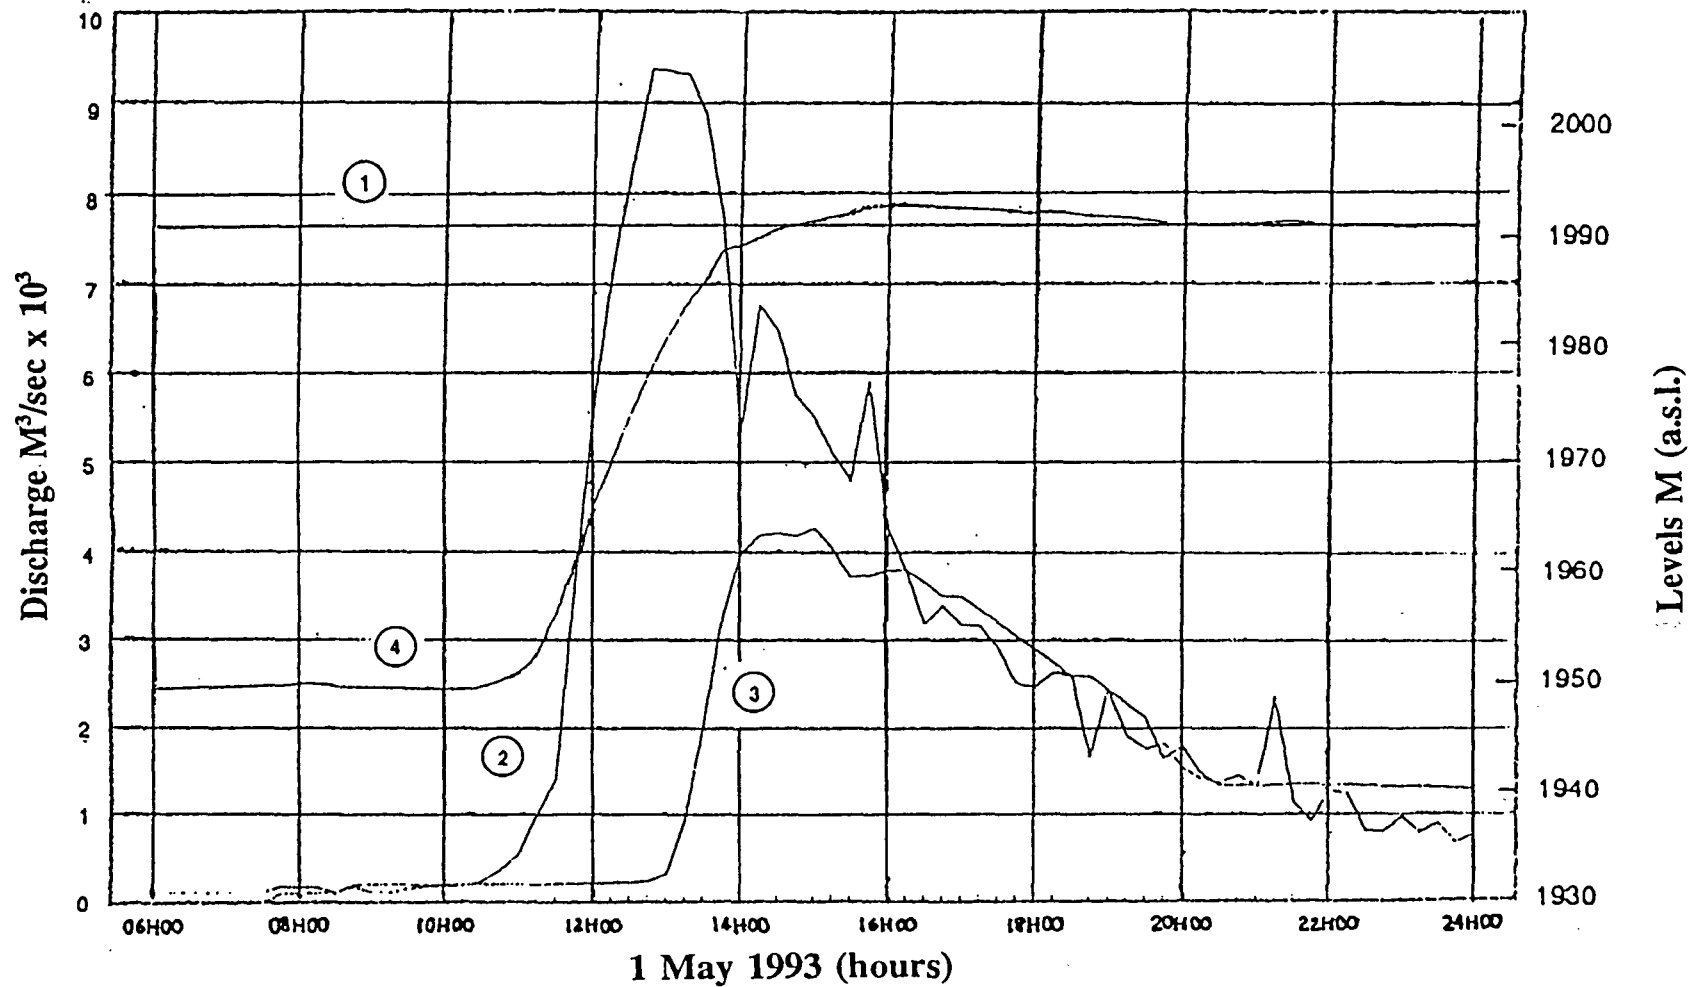
Figure 10: Amaluza Operation at the Drain of the La Josefina Reservoir  
(Hydrograms and Levels)

An average diameter of 100 mm in the bed of the canal, with variations of up to 250 mm/700 mm in the equilibrium profile, was considered for the particle-size conditions. Figures 10 and 11 depict the reduction of water levels and of the crest of the spillover from the canal as a function of time. It may be noted that the duration of the flooding produced by the draining down of the water and the peak flooding are essentially dependent on the presumed particle-size conditions.

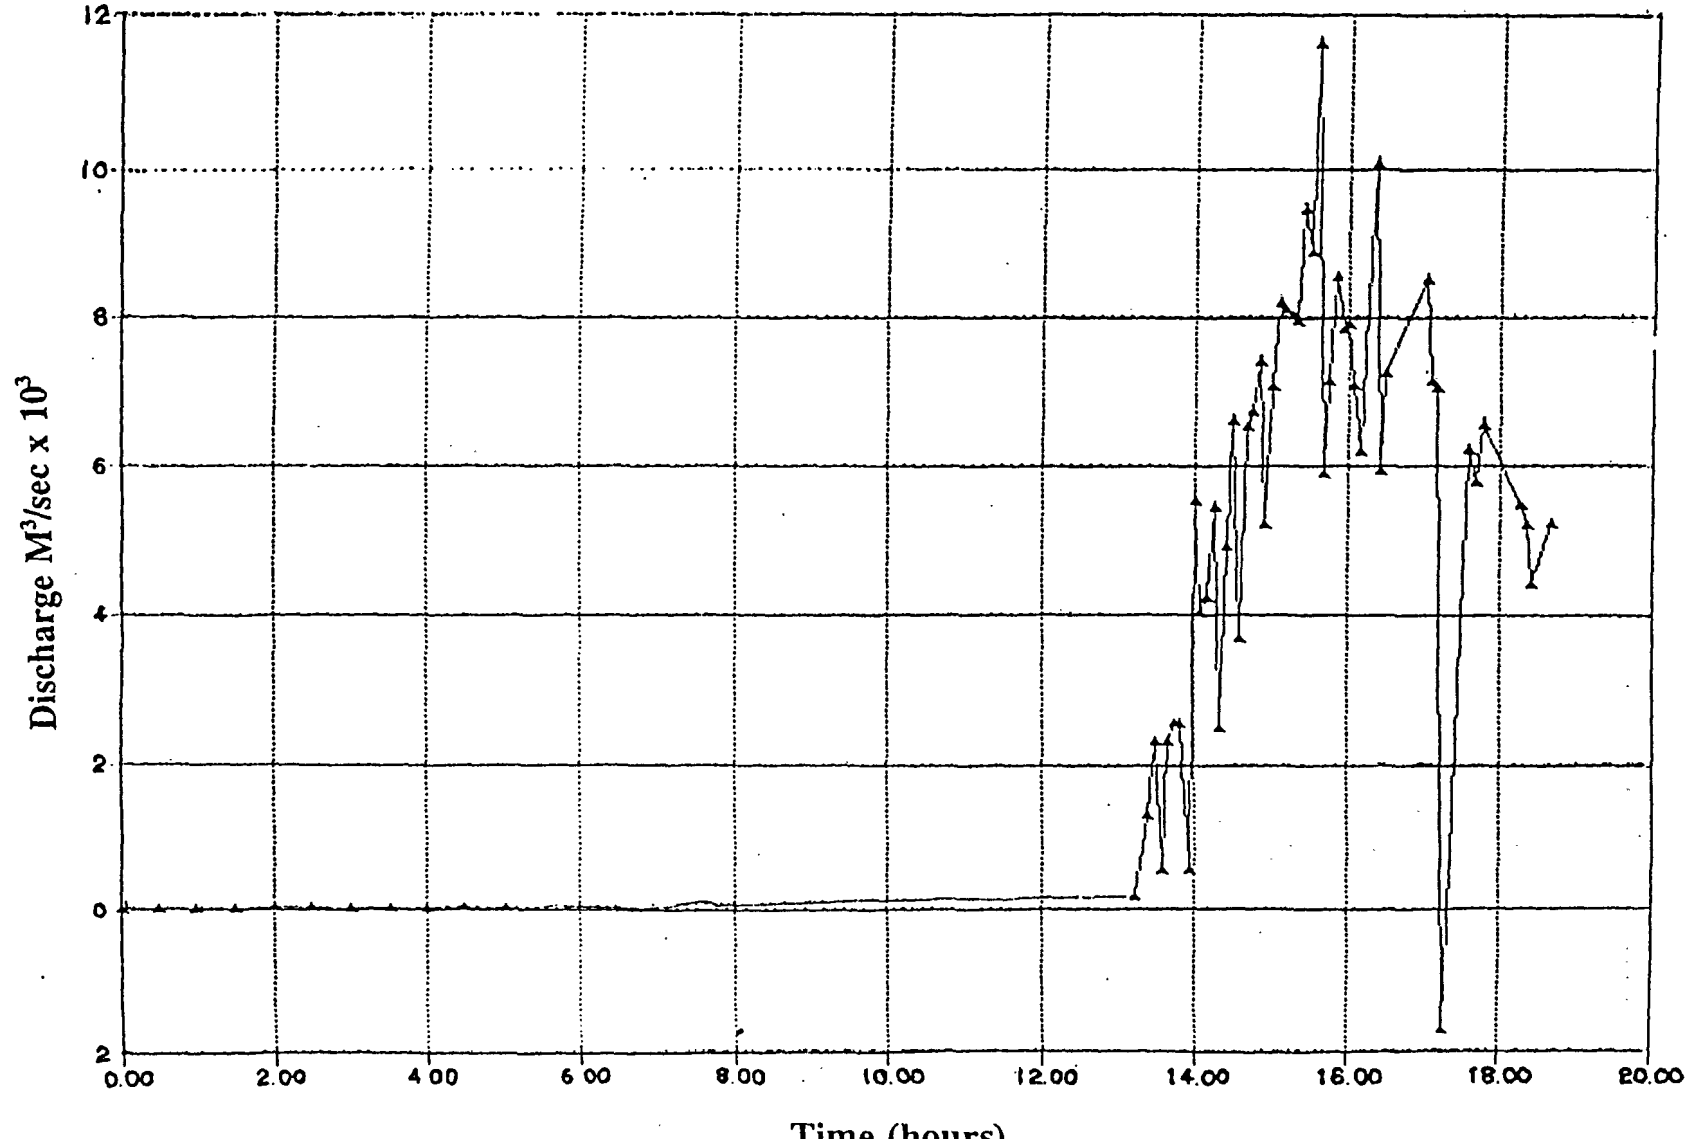
Figure 14: Drainage of the Josefina Reservoir  
(Discharges Thousands M<sup>3</sup>/sec)

10,000 m<sup>3</sup>/s (Figure 14). A dam of the arch-gravity type is readily able to withstand the excess pressures due to a water level 2.50 m higher than the peak operating level and should have been designed for such an eventuality. This dam could therefore tolerate water flowing over its top without being destroyed, obviously with some minor damage in some electro-mechanical parts and in the works located at the foot of the dam.
