**Letter dated 20 May 2019 from the Permanent Representative of
the Russian Federation to the United Nations addressed to the
Secretary-General and the President of the Security Council**

Aide-memoire from the Russian Federation on Russian assessments of the report¹ of the Organisation for the Prohibition of Chemical Weapons fact-finding mission in the Syrian Arab Republic regarding an incident in which toxic chemicals were alleged to have been used as a weapon in Douma, Syrian Arab Republic, on 7 April 2018

Disproof of the hypothesis, that the cylinder was dropped from an aircraft at Location 2

Disproof of the hypothesis, that the cylinder was dropped from an aircraft at Location 4

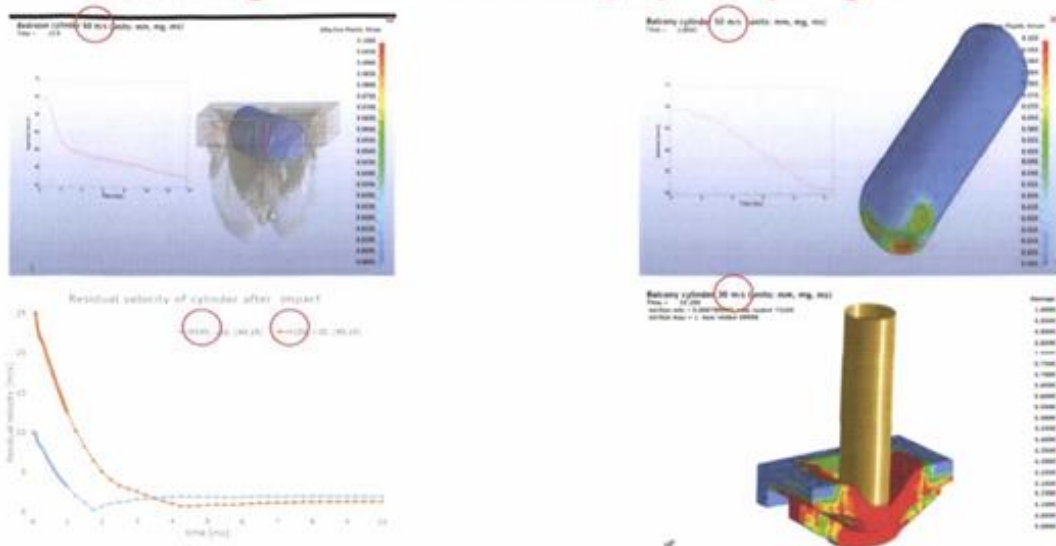
According to the diagrams and figures in the report (figures 10, A.6.6 and A.6.7(b)), the calculation was carried out for the collision of a cylinder with an obstacle at a speed of from 30 to 60 m/s, which corresponds to a drop height of from 45 to 180 m. Figure 12 shows the schedule of residual speeds of cylinders when dropped from a height of 150 m.

However, owing to security concerns, Syrian air force helicopters do not fly over human settlements at altitudes below 2,000 m. A helicopter flying at an altitude of 200 m over an area of hostilities will be targeted at the very least by small arms and will definitely be shot down.

If the cylinder were dropped from such a height, it would have reached a vertical speed of about 200 m/s at the time of impact and would definitely not only have penetrated the roof (20 cm thick) but also have sustained significant damage.

The assessment of the interaction of the cylinders with the roof of the buildings was made for the improper drop heights

The calculation was carried out for the conditions of the collision of the cylinder with the barrier at a speed of 30-60 meters per second. It is consistent with the drop heights assumed between 45 m and 180 m

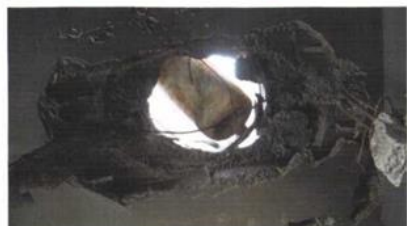
A detailed study of the aperture in the reinforced concrete obstacle, and also the scorch marks and the destruction of the rebar inside the aperture, are more consistent with the explosion of a 120 mm mortar shell or artillery projectile of the same calibre approaching the obstacle on a high-angle trajectory. The fragments on the balcony walls attest to this. The likelihood that the funnel was formed by a mortar/artillery shell or similar ammunition is also confirmed by the presence of more than one very similar aperture in the concrete slabs at the top of nearby buildings (figure A.6.3).

Black scorching on the crater and the destruction of steel rebar inside the aperture

Traces of blast fragmentations on the balcony's walls

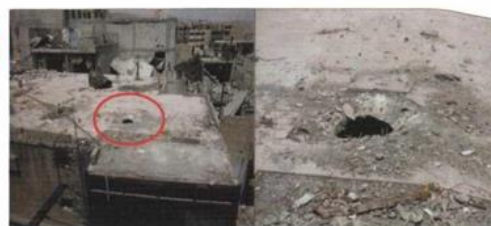
Presence of more than one crater of very similar appearance in concrete slabs on top of nearby buildings

Indications and signs, expected as a result of a blast of a 120-mm HE mortar shell or artillery projectile of the same caliber

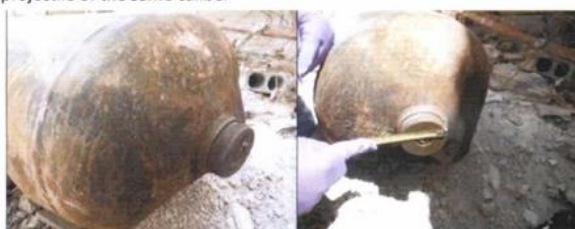
At Location 2, the shape and dimensions of the resulting aperture are more consistent with the penetration of a solid body through the reinforced concrete obstacle at an angle of 80–90 degrees from the surface. This is consistent with the deformation of the rebar of the obstacle (the roof of the building).

The condition of the observed cylinder is not consistent with the deformation that a cylinder full of liquid chlorine would sustain under the above-mentioned circumstances. The front end of the cylinder would have sustained more significant deformation in the penetration described.

The shape and dimensions of the resulting aperture are consistent with the penetration of a solid body through the reinforced concrete barrier under the angle of 80-90 °

The cylinder's condition is not consistent with the deformation and damage it could suffer. The cylinder's front end should suffer much more significant deformation

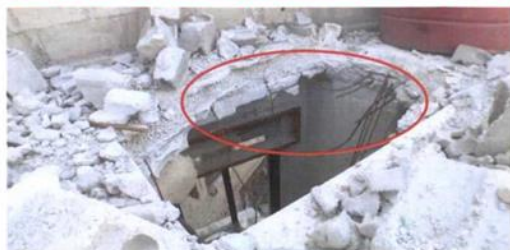
At Location 4, the size of the aperture is not consistent with the size of the cylinder found on the bed inside the room. The cross section of the aperture is more than twice the diameter of the cylinder, which contradicts the calculated and practical results for solid bodies penetrating reinforced concrete obstacles.

The presence of protruding mild steel rebar within the aperture indicates that it had been expanded from the outside; it is less indicative of the aperture being caused by penetration of a solid body.

A crater in the roof has dimensions of 166 x 105 cm
The presence of fragments of mild steel rebar inside the crater and wire netting indicates that it has been widened mechanically and intentionally

The cylinder found has dimensions of 140 x 35 cm

The lateral dimensions of the crater outmeasure the cylinder's diameter more than twofold. It does not comply with the calculated and practical results, expected after the penetration of solid bodies through the reinforced concrete barriers

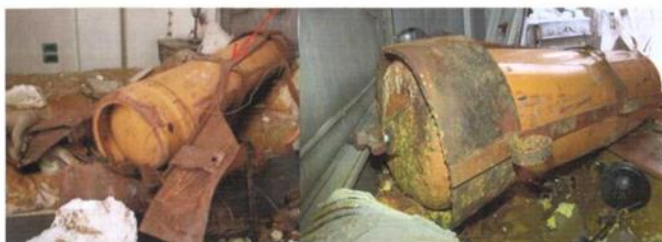
The condition of the cylinder described is not consistent with the deformation that a cylinder full of liquid chlorine would sustain under the conditions described. Under those conditions of penetration, the body of the cylinder would have a more flattened form, and the stabilizing fins, the valve and other elements would be severely deformed or missing.

The cylinder should have more flattened form for the flat penetration. The stabilizing fins, valve and other elements should have more significant deformation or be absent

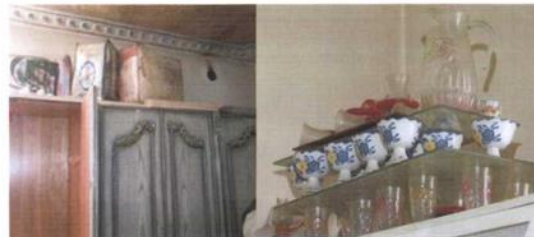
The conditions in which the cylinder entered the top floor room do not allow for its subsequent lateral deflection from the path of penetration without causing concomitant damage to the furniture, floors, walls and windows, but no traces of such damage are observed.

The penetration of the cylinder inside the top floor apartment does not allow its subsequent deflection laterally post-impact within the room without causing related damage to the furniture, floor, walls and windows of the room
