普遍彻底裁军：《关于禁止发展、生产、储存和使用  
化学武器及销毁此种武器的公约》的执行情况

### 俄罗斯联邦关于俄罗斯对禁止化学武器组织阿拉伯叙利亚共和国事实调查组关于在阿拉伯叙利亚共和国的杜马发生的将有毒化学品用作武器的指称事件(2018年4月7日)的报告<sup>1</sup> 的评估的备忘录

**Discrepancies observed while comparing the results of chemical analysis by two OPCW designated laboratories**

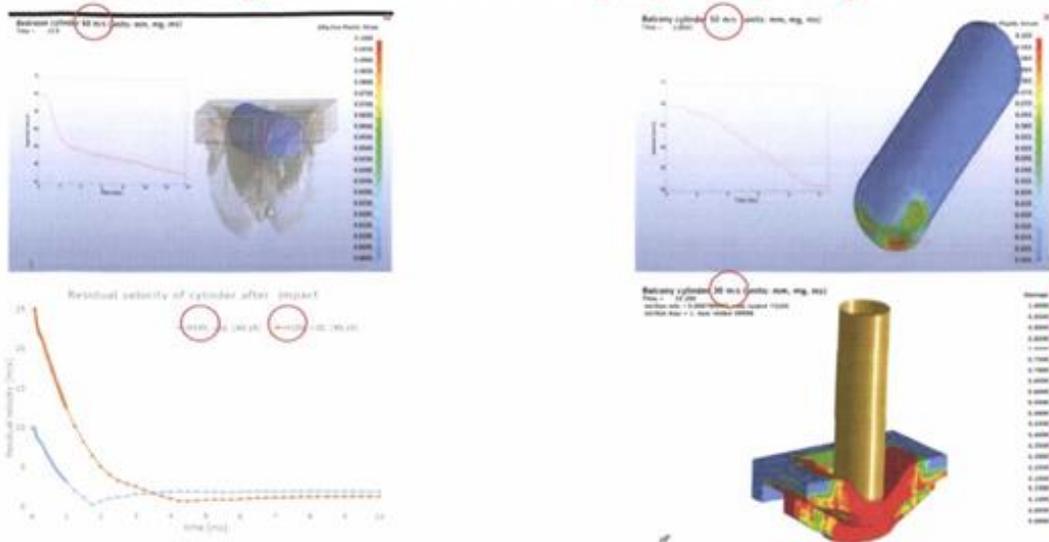
**The assessment of the interaction of the cylinders with the roof of the buildings was made for the improper drop heights**

The calculation was carried out for the conditions of the collision of the cylinder with the barrier at a speed of 30-60 meters per second. It is consistent with the drop heights assumed between 45 m and 180 m

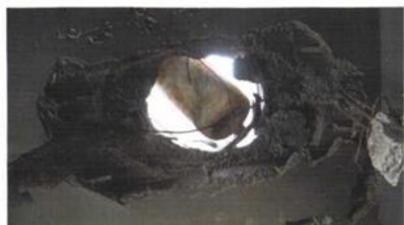
对钢筋混凝土障碍物上的孔, 还有孔内钢筋的烧焦痕迹和损坏的详细研究发现, 情况与 120 毫米迫击炮弹或相同口径炮弹在大角度轨道上靠近障碍物时的爆炸更加一致。阳台墙壁上的碎片也证明了这一点。在附近建筑物顶部的混凝土板上有不止一个外观非常相似的孔(图 A.6.3), 也证实了漏孔是由迫击炮/炮弹或类似的弹药造成的可能性。

Black scorching on the crater and the destruction of steel rebar inside the aperture

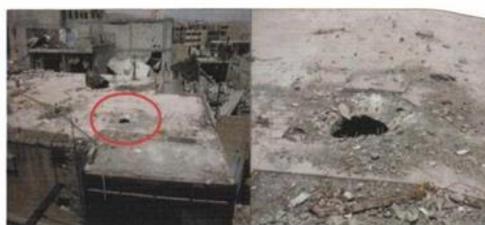
Presence of more than one crater of very similar appearance in concrete slabs on top of nearby buildings

Indications and signs, expected as a result of a blast of a 120-mm HE mortar shell or artillery projectile of the same caliber

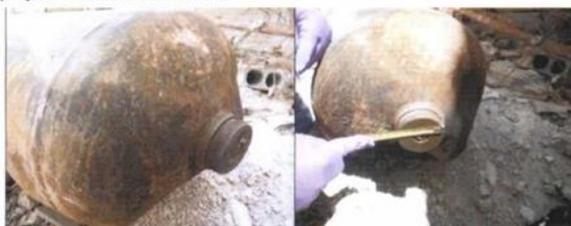
在 2 号地点, 所造成的孔的形状和尺寸与固体以与表面成 80-90 度的角度穿过钢筋混凝土障碍物的情况更加一致。这与障碍物(建筑物屋顶)钢筋的变形一致。

观察到的钢瓶的状况与装满液态氯的钢瓶在上述情况下应遭受的变形不一致。钢瓶的前端应该会在所描述的穿越中遭到更大的变形。

The shape and dimensions of the resulting aperture are consistent with the penetration of a solid body through the reinforced concrete barrier under the angle of 80-90 °

The cylinder's condition is not consistent with the deformation and damage it could suffer. The cylinder's front end should suffer much more significant deformation

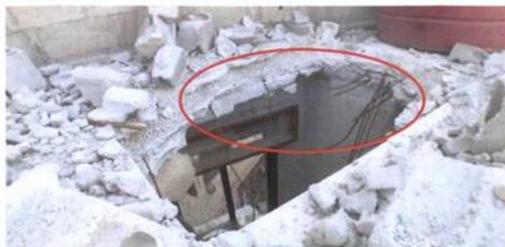
在 4 号地点, 孔的尺寸与公寓内的床上发现的钢瓶的尺寸不一致。孔的横截面是钢瓶直径的两倍以上。这与固体穿越钢筋混凝土障碍物的计算结果和实际结果相矛盾。

孔内存在突出的低碳钢筋表明, 孔已被从外部扩大; 情况表明, 孔不大可能是由固体的穿越引起的。

A crater in the roof has dimensions of 166 x 105 cm  
The presence of fragments of mild steel rebar inside the crater and wire netting indicates that it has been widened mechanically and intentionally

The cylinder found has dimensions of 140 x 35 cm

The lateral dimensions of the crater outmeasure the cylinder's diameter more than twofold. It does not comply with the calculated and practical results, expected after the penetration of solid bodies through the reinforced concrete barriers

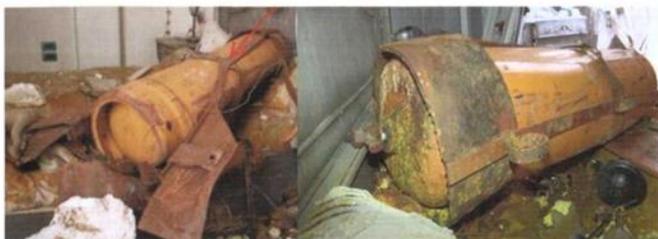
所述钢瓶的状况与装满液态氯的钢瓶在所述条件下遭受的变形不一致。在这些穿透条件下, 钢瓶主体应呈更扁平的形状。稳定翼片、阀门和其他元件应遭受更大的变形或被撞飞。

The cylinder should have more flattened form for the flat penetration. The stabilizing fins, valve and other elements should have more significant deformation or be absent

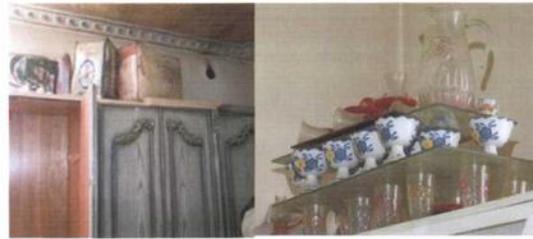
钢瓶进入顶层房间的条件不允许其随后横向偏离穿透路径而不会对家具、地板、墙壁和窗户造成伴随的损坏, 但是没有观察到这种损坏的痕迹。

The penetration of the cylinder inside the top floor apartment does not allow its subsequent deflection laterally post-impact within the room without causing related damage to the furniture, floor, walls and windows of the room
