Carta de fecha 27 de junio de 2019 dirigida al Secretario General por el Encargado de Negocios Interino de la Misión Permanente de los Estados Unidos de América ante las Naciones Unidas

UNCLASSIFIED U.S.
ASSESSMENT OF RECENT INCIDENTS
IN THE PERSIAN GULF

M/V KOKUKA COURAGEOUS Attacked With Iranian Indigenous Extra-Large Limpet Mines (High Confidence)

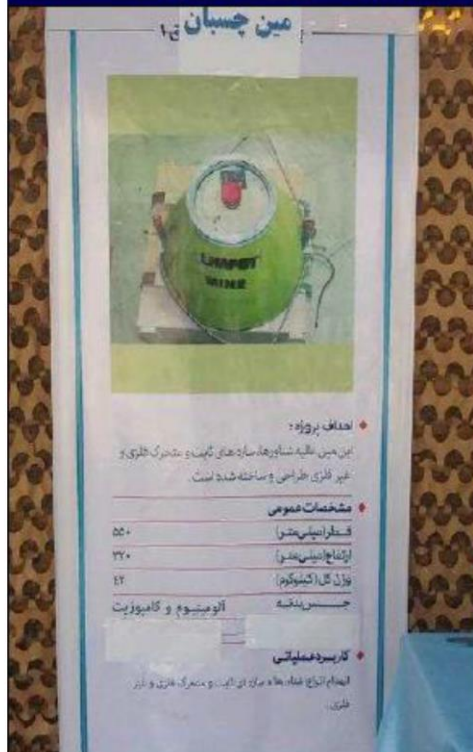
(U) Brochure for Iranian Indigenous Extra-Large Limpet Mine, Publicly Revealed at 2015 Military Display

Project Objectives: This mine has been designed and built to be used against vessels and fixed and mobile metallic and non-metallic structure.

General Specifications:

Diameter (mm): 550

Height (mm): 320

Weight (kg): 42

Casing: Aluminum and Composite

(U) The green composite material on the recovered magnet, location of the cartridge-actuated nail holes, number of nail holes, and diameter of the limpet placement area is consistent with the Iranian "Indigenous Extra-Large" limpet mine advertised in a 2015 arms display. Chemical analysis of collected explosive residue swabs is pending.

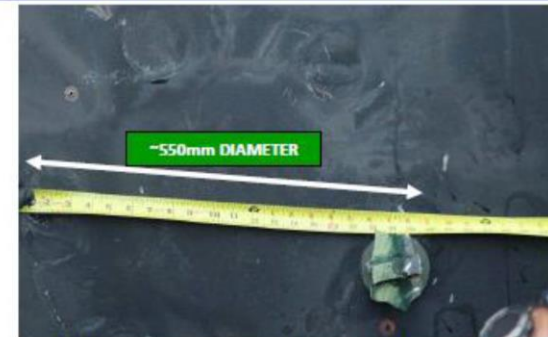
(U) Measurements are consistent with reported diameter of Iranian Extra-Large limpet mine

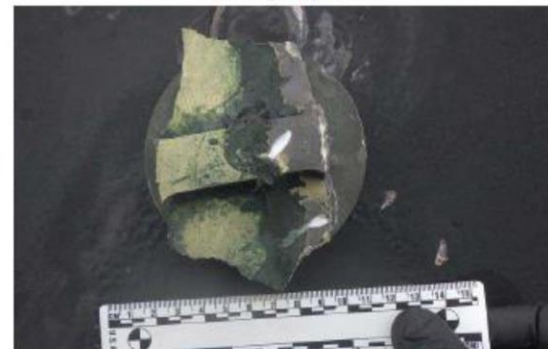
(U) Magnet 3.5" diameter; aluminum, composite remnants

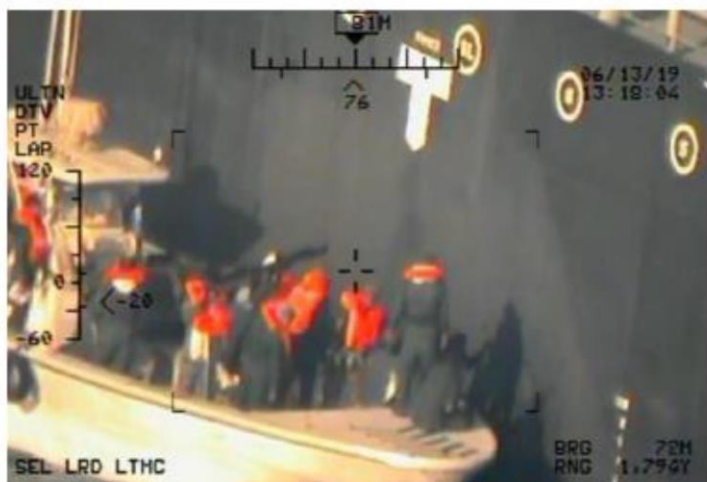
Photos from an MH-60R on Jun 13, 2019

Imagery taken from a U.S. Navy MH-60R helicopter of the Islamic Revolutionary Guard Corps Navy removing an unexploded limpet mine from the M/T Kokuka Courageous.

The Motor Tanker (M/T) Kokuka Courageous sustained damage from a limpet mine attack while operating in the Gulf of Oman, on June 13th. Limpet mines are attached to a vessel via magnets and/or nails and detonated by a timer. Following the attack, sailors from the Kokuka Couragous discovered a second, unexploded, limpet mine on their vessel and abandoned ship. The Dutch tug Coastal Ace rescued the crew of 21 sailors. The USS Bainbridge (DDG 96) then transferred and transported the Sailors to safety. Later that day, an Islamic Revolutionary Guard Corps (IRGC) Gashti Class patrol boat approached Kokuka Courageous and was observed and recorded by a U.S. Navy MH-60R helicopter removing the unexploded limpet mine from Kokuka Courageous. Iran is responsible for the attack based on video evidence and the resources and proficiency needed to quickly remove the unexploded limpet mine. The hull penetration measures 1.1m at the widest point by 1.5m 4'2" x 3'8" (H x W) at the tallest point. The penetration begins approximately 1m above the water line.

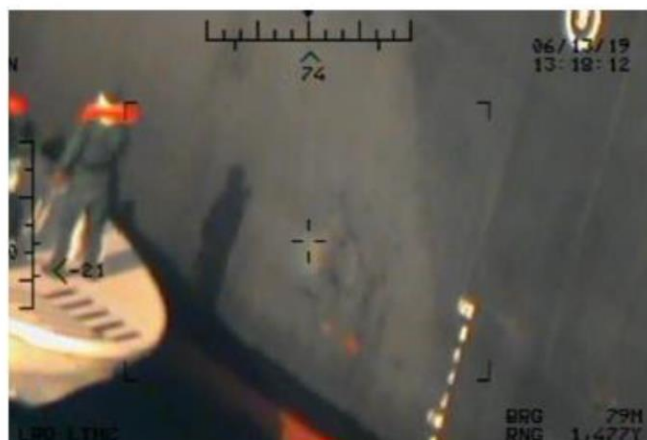
Imagery taken from a U.S. Navy MH-60R helicopter of the Islamic Revolutionary Guard Corps Navy after removing an unexploded limpet mine from the M/T Kokuka Courageous.

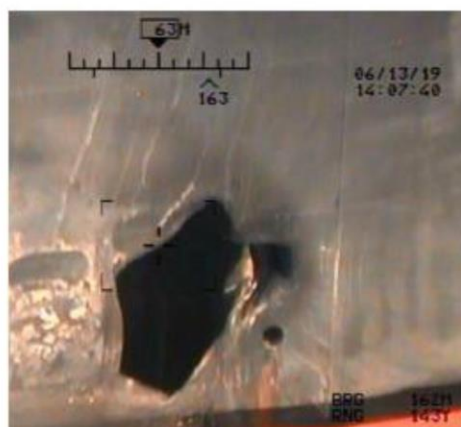
Imagery taken from a U.S. Navy MH-60R helicopter of blast damage to M/T Kokuka Courageous. M/V Kokuka Courageous received damage consistent with a limpet mine attack in the Gulf of Oman, June 13.

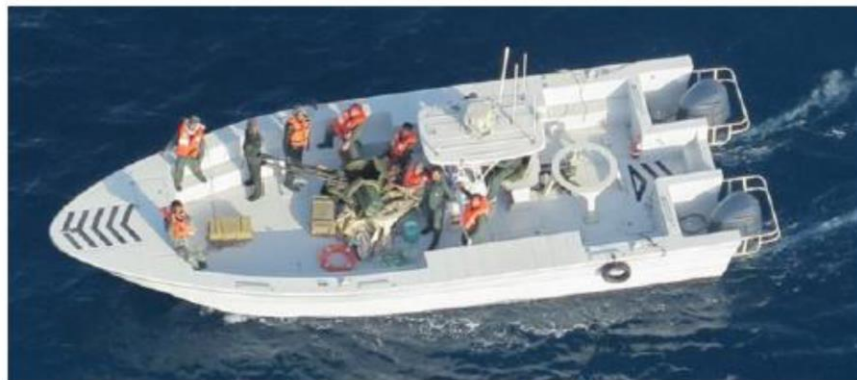
Imagery taken from a U.S. Navy MH-60R helicopter of the Islamic Revolutionary Guard Corps Navy after removing an unexploded limpet mine from the M/T Kokuka Courageous.

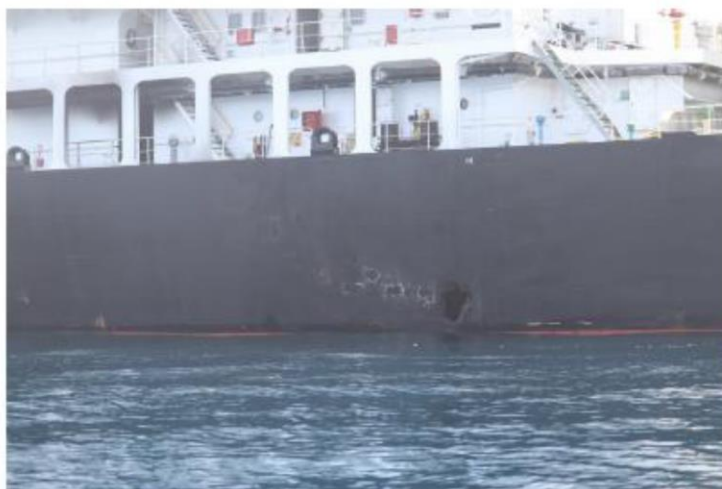
Photos of Damage and Mine Remnants taken June 14.

7710 - This is a view of hull penetration/blast damage on the starboard side of motor vessel M/T Kokuka Courageous, which was sustained from a limpet mine attack while operating in the Gulf of Oman, on June 13th.

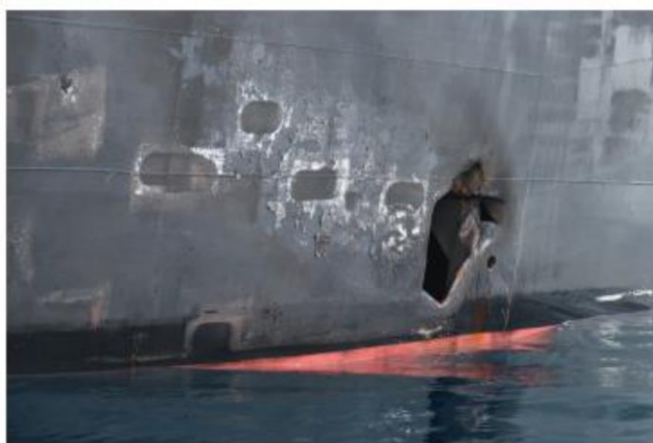
7725 - This photo is a view of hull penetration/blast damage sustained from a limpet mine attack on the starboard side of motor vessel M/T Kokuka Courageous, while operating in the Gulf of Oman, June 13.

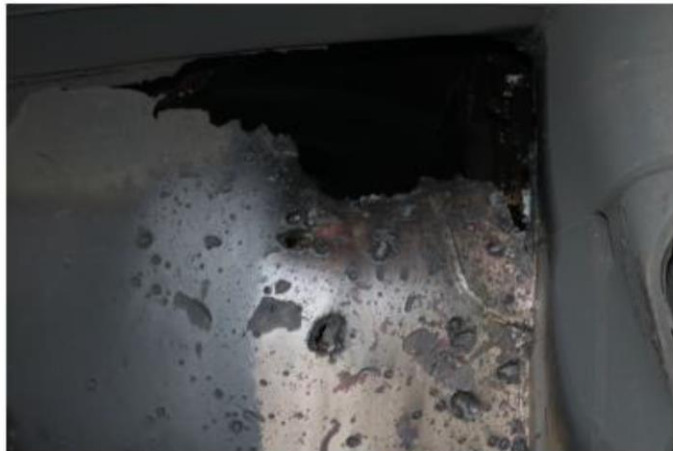
7729 - This photo is a view of internal hull penetration/blast damage sustained from a limpet mine attack on the starboard side of motor vessel M/T Kokuka Courageous, while operating in the Gulf of Oman, June 13.

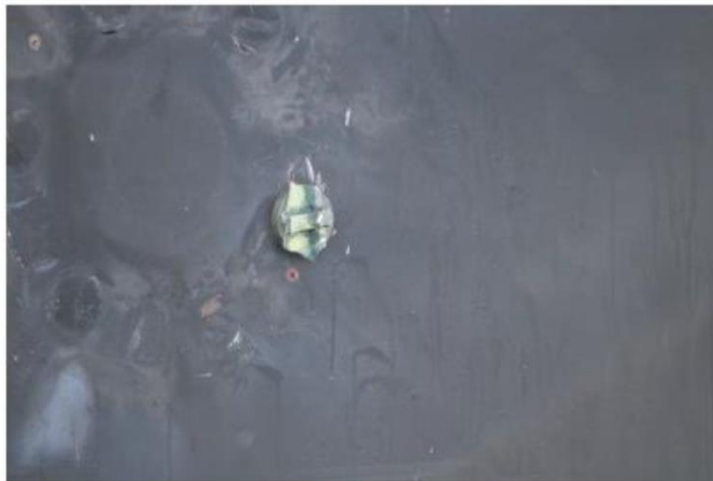
7714 - This is the view of the remnants of a removed limpet mine's placement, location, and damage sustained from a limpet mine attack, on the starboard side of motor vessel M/T Kokuka Courageous, while operating in the Gulf of Oman, June 13. A limpet mine is attached to a vessel via magnet and/or nails. The holes seen were created by nails used to hold the mine in place.

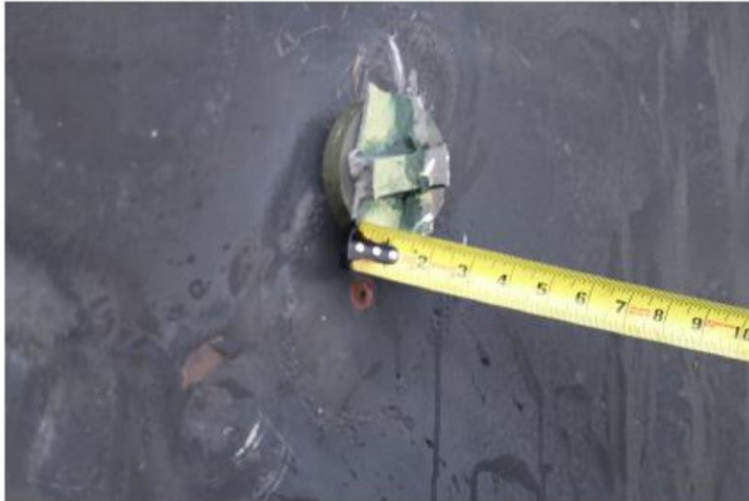
7761 -This photo depicts the aluminum and green composite material left behind following removal of an unexploded limpet mine used in an attack on the starboard side of motor vessel M/T Kokuka Courageous, while operating in the Gulf of Oman, June 13th.
