COMMISSION ON NARCOTIC DRUGS

Former Japanese Narcotic Factory in Mukden, Manchuria

- I. Letter of Dr. A. H. Homeyer, expert on the manufacture of opium alkaloids, giving opinion on the potential morphine and heroin manufacture of the former Japanese factory in Mukden, Manchuria.
- II. Photographs showing former Japanese narcotic factory in Mukden, Manchuria.

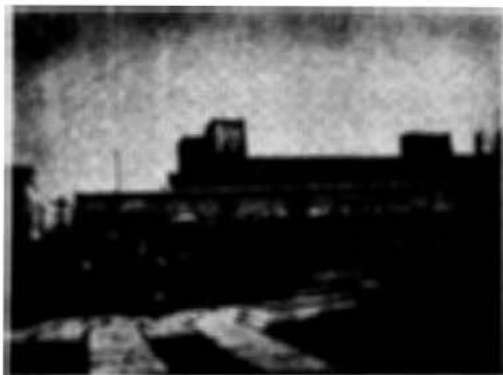
No. 1. The compound close to the front gate.

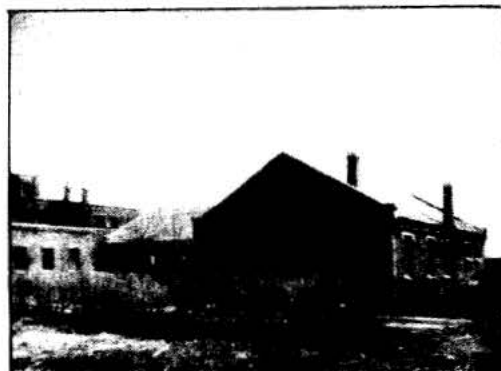
No. 2. The administrative building in the compound.

It is my impression that the plant included administration (picture No. 2), garage (3), transformer (4), and power plant (10) buildings and that there were at least six and probably more other buildings shown partly in pictures No. 1, 4, 7, 11, 14, 15. Some of this space was for storage of raw materials, empty containers and finished products, and for packaging, mechanical shop, laboratory services, etc. The main manufacturing buildings are shown in pictures No. 11, 14, and 15.

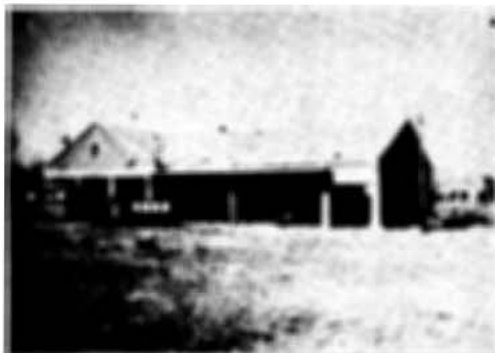
No. 3. The extension of the administrative building used as a garage.

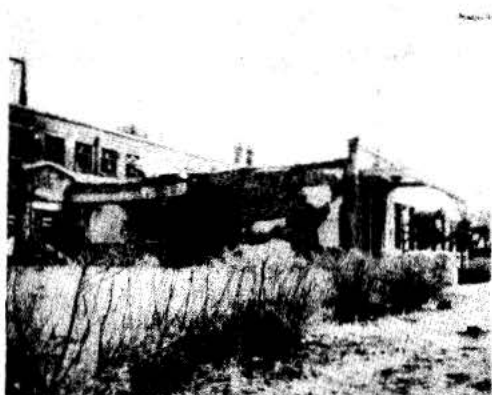
No. 5. Another half of the building that the bombs missed.

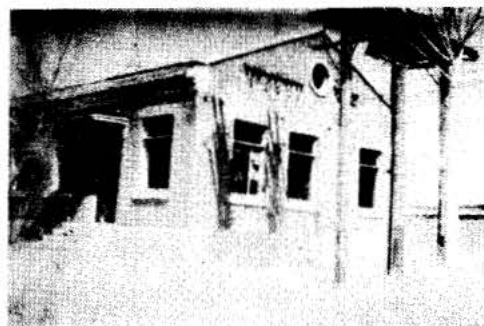
No. 6. This is the house for the power units.

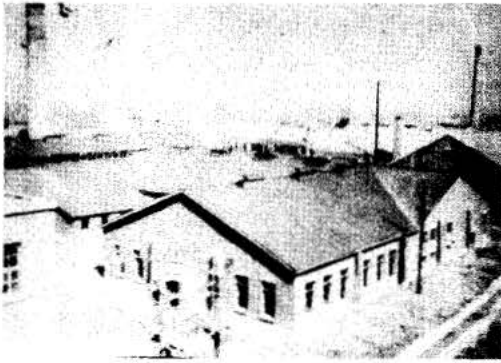
No. 7. Bird's eye view of the most concentrated part of the compound, where the old installation was placed.

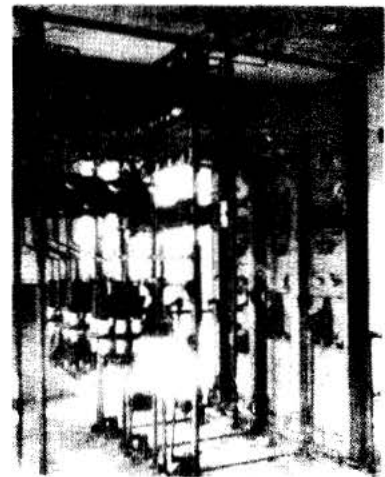
No. 8. A switch board in the transformer unit which was badly looted and important parts were taken away.

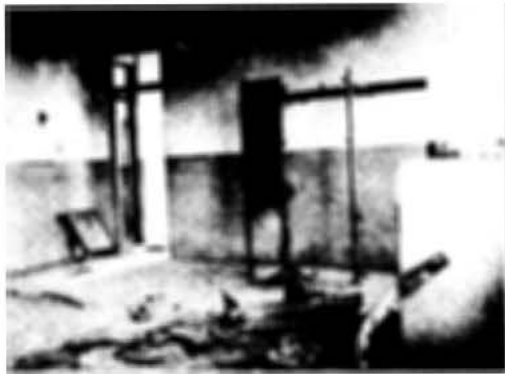
No. 9. The picture shows that the room was barely stripped.

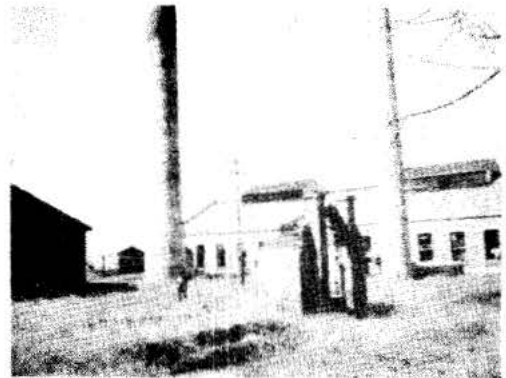
No. 10. The remains of a house bombed in the central yard.

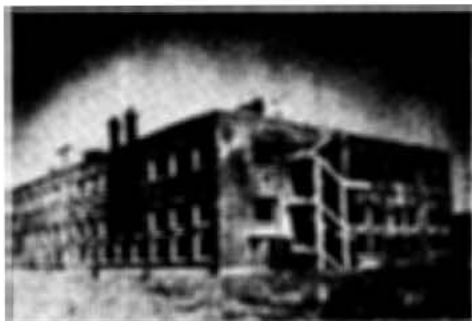
No. 11. The lateral and front view of the main production building where most of the new equipment were installed.

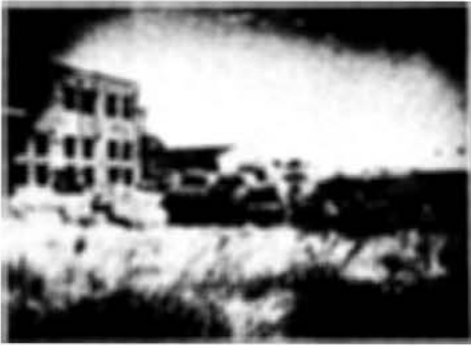
No. 13. This is a little hill of different sizes of tanks and boilers, including supports. Most of them is lined with lead or enamel. They are new and some of them are in crates. This heap lies in the left of the building described above.

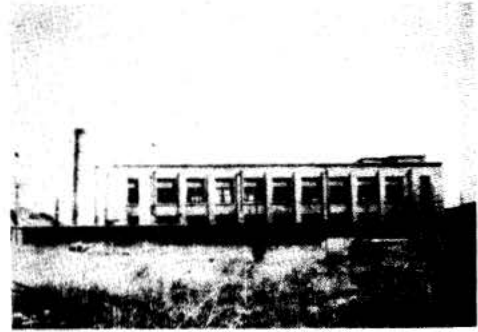
No. 14. This is another new two-storey building, situated right of the building in picture 11. Most of the installed machinery have been removed. The building is still good.

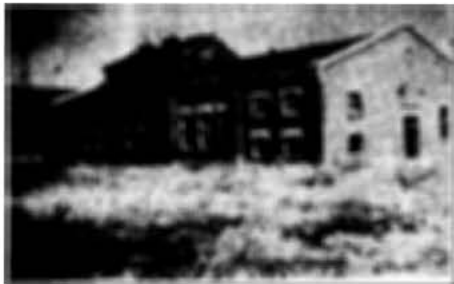
No. 15. One of the buildings in the compound, inside which heavy machinery was to be installed.

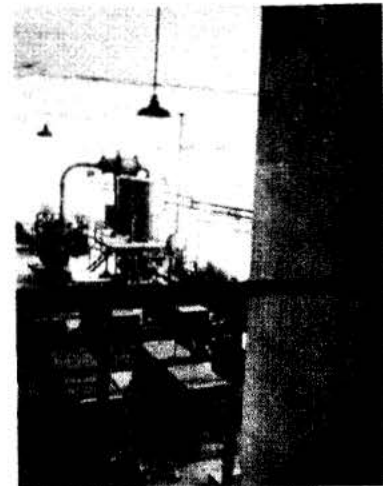
The best indication of opium extraction capacity is from the equipment shown in building No. 11 including two stills about 4' X 9' (16, 17, 18, 21), three large plate and frame type filter presses about 30" X 30" X 10' (16, 17, 21) and 11 jacketed kettles of about 100 gallon capacity (17, 18). A large centrifugal or drum type filter, two pressure tanks and two kettles show in picture 22. There are five more jacketed kettles and several reciprocating steam driven pumps in picture 23. Other equipment such as storage tanks for liquors which may be upstairs would be necessary as accessories but the capacity would be set by that mentioned before. These facilities would provide for filtration of opium extracts, concentration of the solution and crystallization of the morphine salts for purification. The capacity would depend on time cycles, efficiency of recovery and purity of product desired. Building 11 seems to have enough artificial illumination for night operation. It seems to me that working 24 hours per day its capacity might be 400,000 kilos of opium per year. This might yield around 50,000 kilos of morphine alkaloid.

No. 16. A general view of the ground floor of the building mentioned in picture 11.

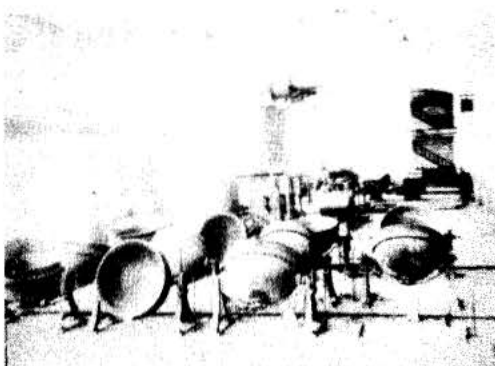
No. 17. The heavy filter presses are seen in the far end. The gigantic distilling unit in the middle and the eleven sets of acid-proof phosphorous bronze evapora-

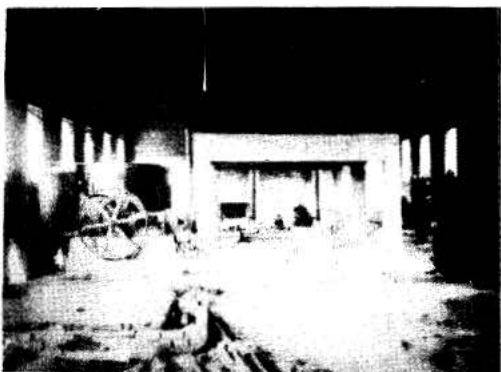
No. 19. One of the interior views of a manufacturing unit. Installations are seen only half erected. Many of these heavy equipments are lying outside of this building with some of them still in crates.

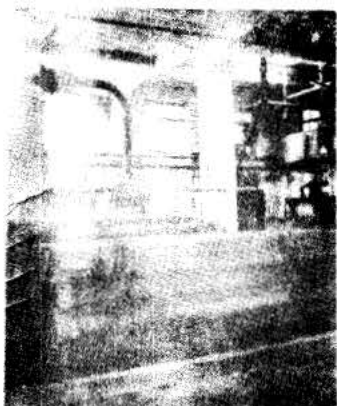
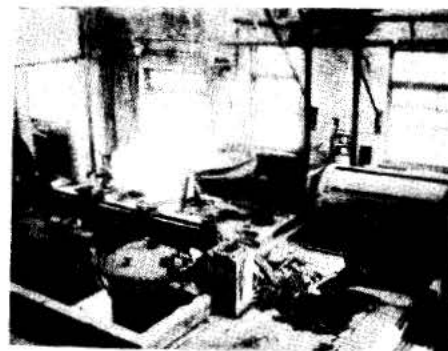
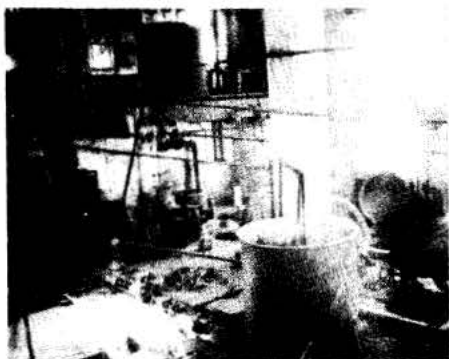
Nos. 21, 22 and 23 are interior views of the building mentioned in picture 11. 21, shows big press filters, lying in one of the distillating units. 22 is a view from the top of the still, where big imbedded tanks and cylindrical centrifuge are seen near another two bigger evaporating pans.

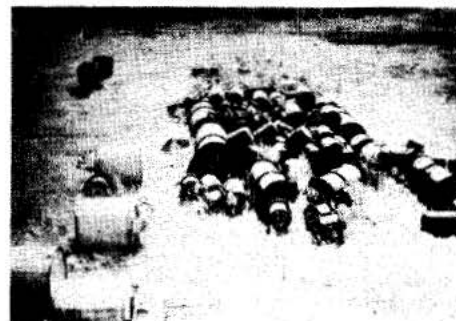
No. 24. Is a view from the top, showing the tanks and other cylinders.

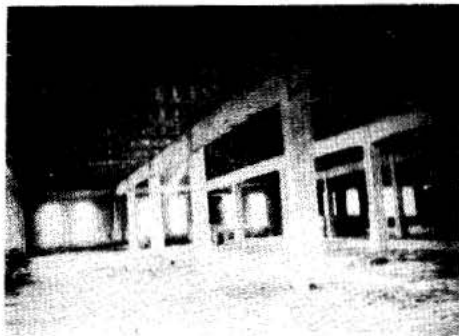
No. 27. Shows the interior of a just completed factory, where installations have not been assembled. The roof of this building is in good condition.

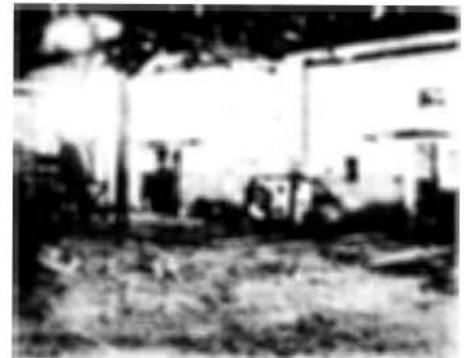
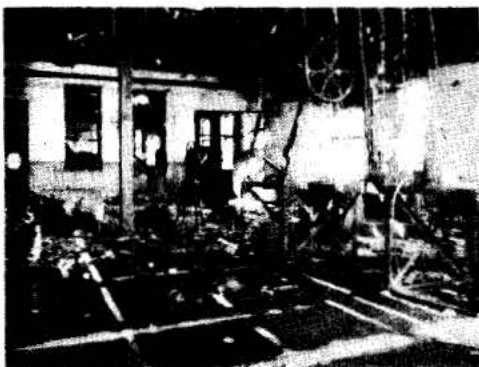
There appears to be a steam heated drier and a mixing tank in picture 28, while No. 29 shows a battery of stirred tanks possibly for mixing or extraction. Picture 30 shows two medium size filter presses, three jacketed kettles, two large hods and about seven or eight tanks of about 500 gallon capacity. Some of this equipment could be used in the production of heroin but its capacity would be difficult to estimate. Picture 31 appears to be a modern interior containing some large horizontal tanks or drum filters. From the size of the rooms and equipment one would judge that they would have a considerable potential output.

Nos. 28 and 29. Shows two badly looted factory units, where work was apparently going on the day it was forced to stop the manufacture. Machinery in these rooms were demolished. Parts of the roofs are torn and the sun is seen through the broken places.

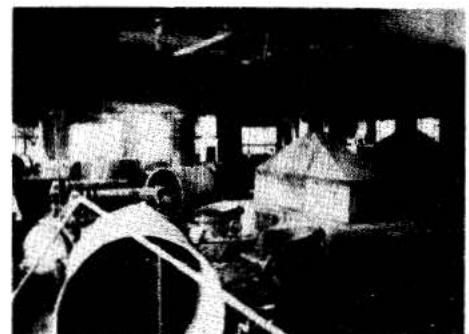
No. 30. The interior of an old manufacturing unit. It consists mostly of old equipments, among them new equipments are added. It was also badly looted.

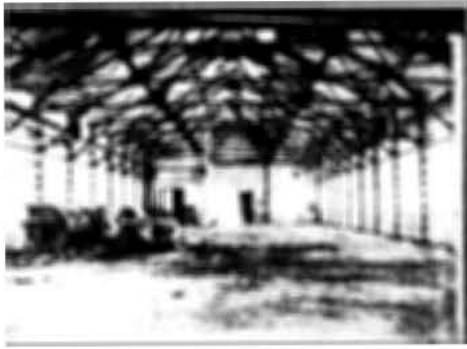
No. 31. The roof of a wellplanned factory.

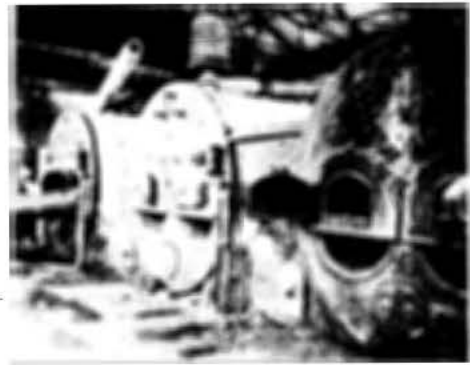
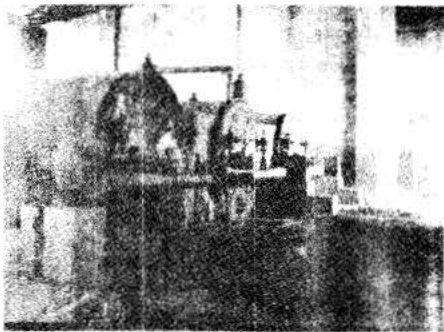
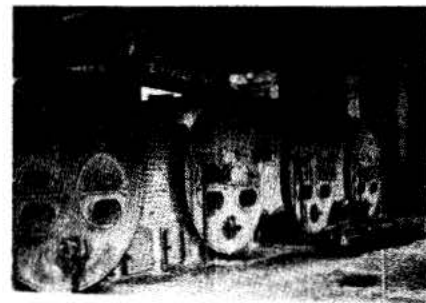
The steam plant shown in pictures 32, 33 and 34 consists of at least 4 boilers about 8 ft. in diameter and may have a steam capacity of 20,000 lbs. per hour. This would be adequate for general heating of the plant as well as all processing needs.

Nos. 32, 33 and 34 are the new boilers installed in the boiler unit. These boilers are new and some of them are equipped with automatic stokers.
