### **Letter dated 14 January 2021 from the Permanent Representative of Yemen to the United Nations addressed to the President of the Security Council**

**Executive summary of the findings of the investigation conducted by the Ministry of the Interior of Yemen and its auxiliary teams into the terrorist attack on and attempted murder of the Prime Minister and the members of the Government in Aden International Airport on 30 December 2020**

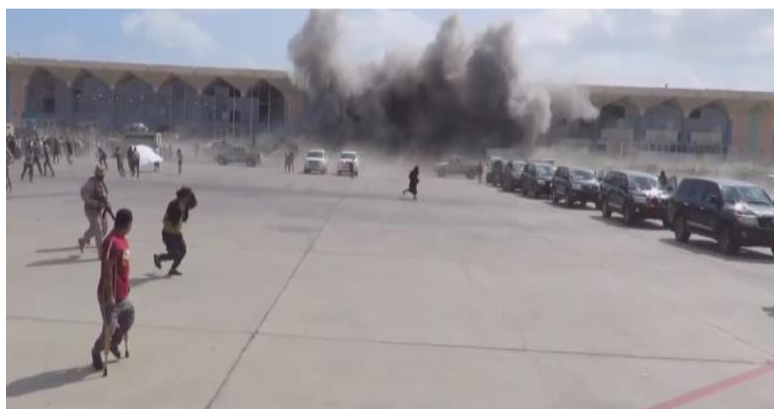
**Image 1**

- At 1324.34 hours, the first missile hit the VIP lounge at coordinates 7852N, 38 P 503968; see image 1.
- The missile penetrated the concrete wall and exploded on the ground floor of the hall, creating a hole with a diameter of 2 metres in the form of a falling arc. This shows clearly the trajectory of the missile from its entry point to its detonation point on the floor of the hall; see images 2, 3, 4 and 5.
- The hall was severely damaged as a result of the explosion; see images 6 and 7.

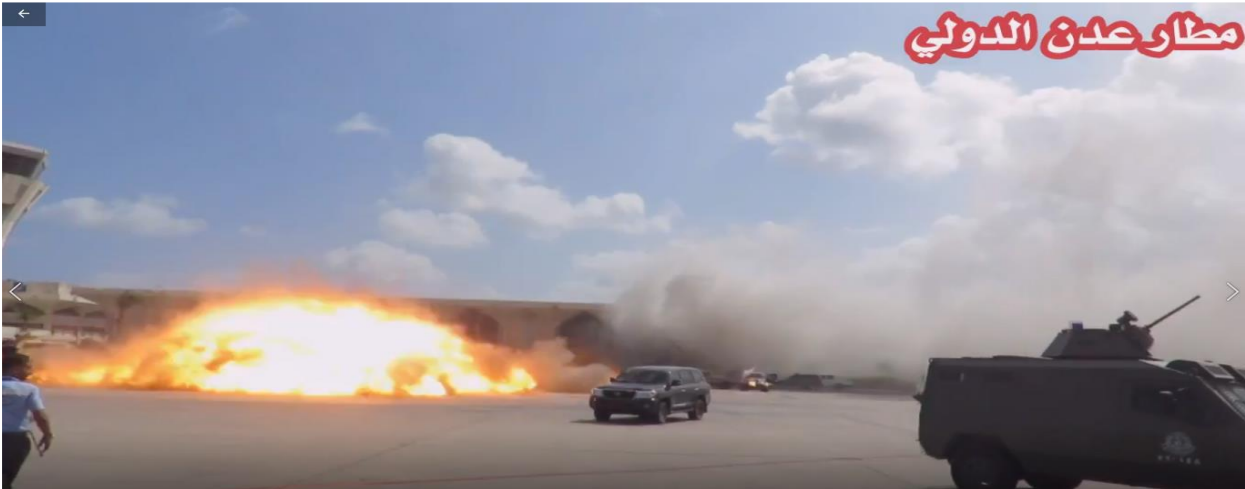
Image 9

- The second missile, which was aimed at runway 1, landed at 1325.9 hours. The aircraft had been scheduled to land on runway 1 but was moved to runway 2 near the pavement around the hall owing to the large numbers of people who had come to meet the arriving passengers; see image 9.

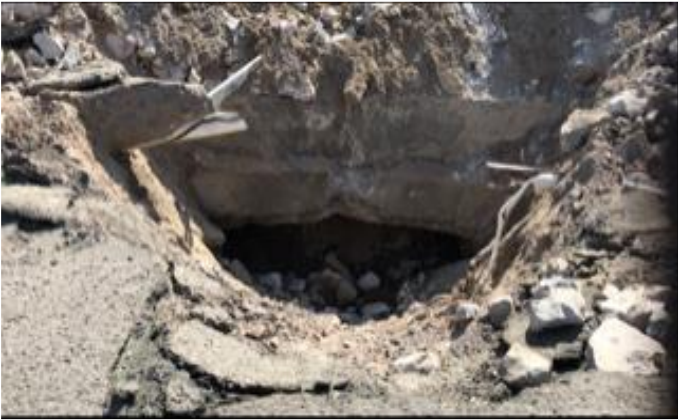
Image 10

- The point of impact is about 30 metres from the impact site of the first missile and some 50 metres from the location where the plane landed.
- The crater created by the impact of the missile is some 3 metres wide and 1.3 metres deep; see image 10.

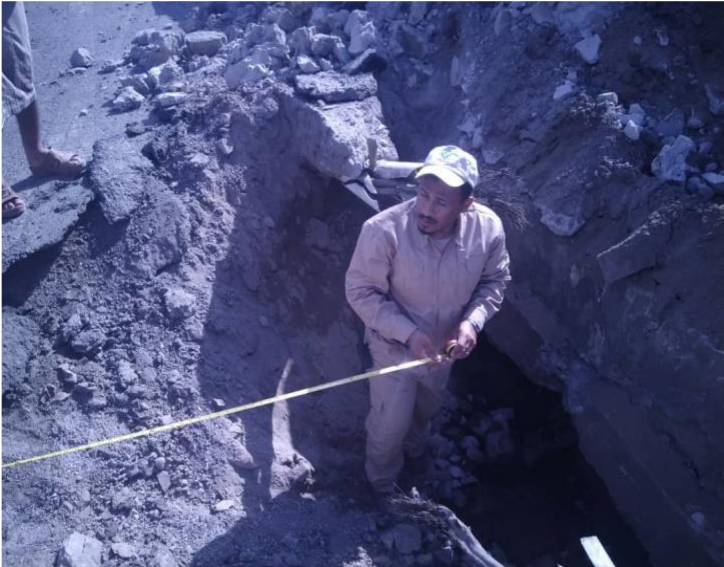
Image 11

- The projectile is believed to have been a high-speed missile. In the crater, it appears to be inclined, indicating its angle of entry. The point and angle of entry match the direction and angle of the blast; see image 11.

- The thick concrete wall of the pavement absorbed the impact shocks, cushioning the damage to the airport.
- The warhead contained an incendiary substance, as can be seen from the image, the extent of the flames and the burnt debris that was left at the site.

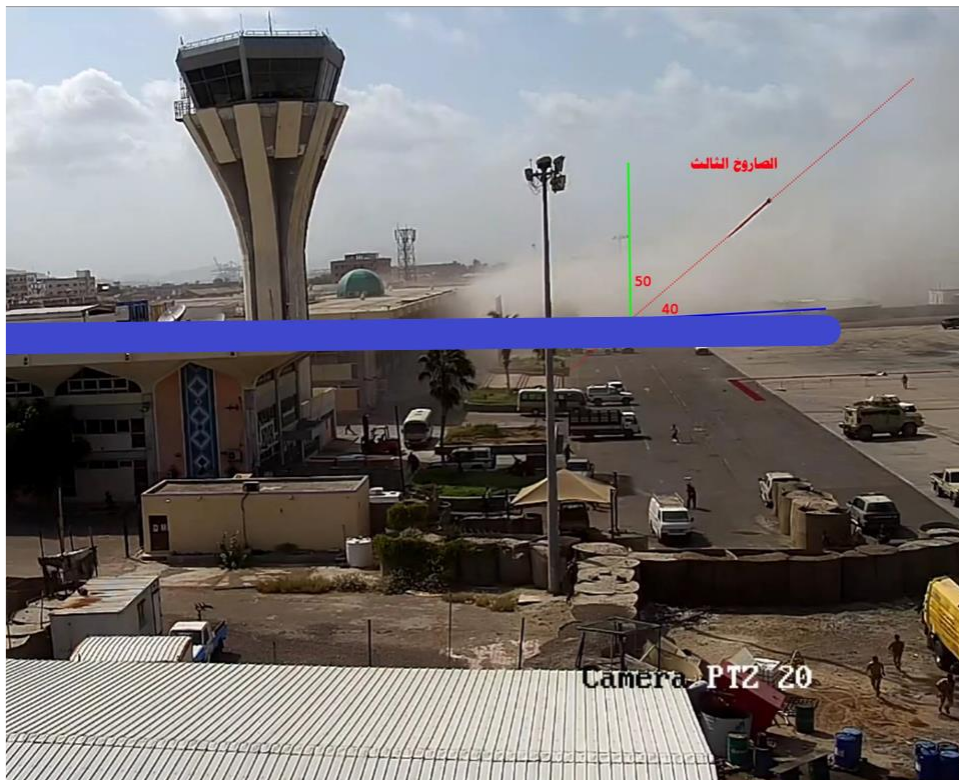
**Image 12**

- The third missile landed at 1325.33 hours, at a site some 15 metres from the first missile and some 50 metres from the location where the aircraft landed; see image 12.
- The diameter of the crater is smaller than that of the other two missiles, at some 75 cm, and the depth is 35 cm; see image 13.
- The explosive charge of the third missile was different from that of the first and second missiles, and the debris found near the point of impact is also of a different type.

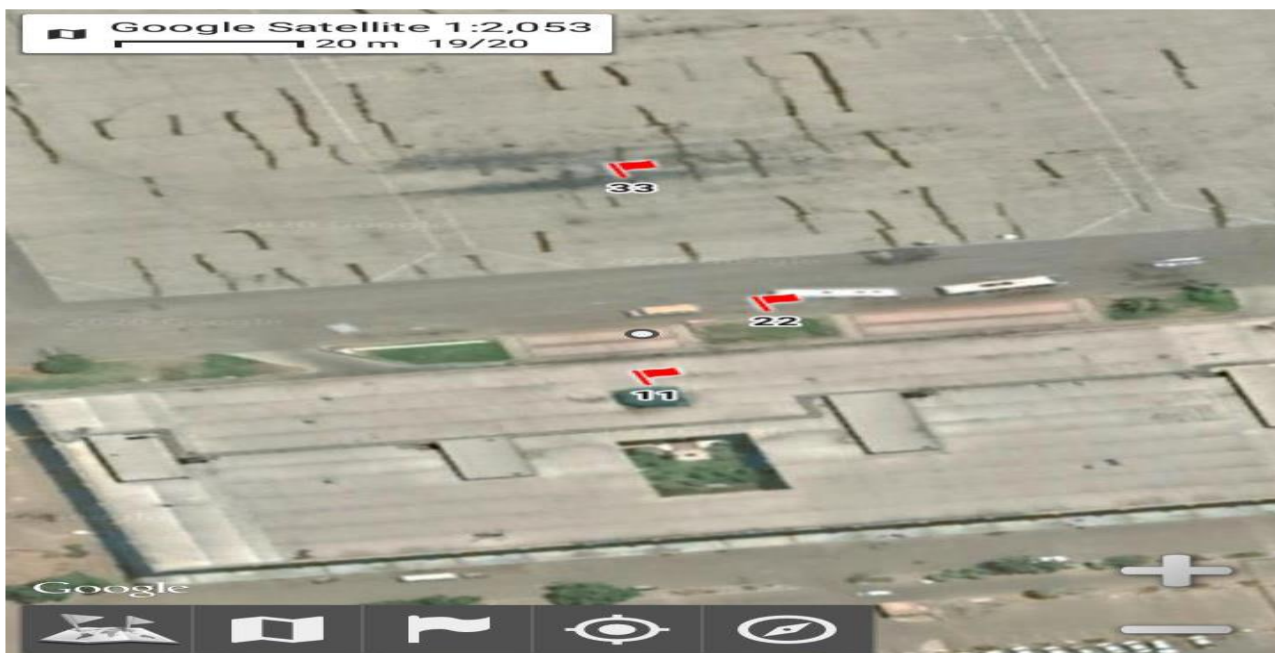
Image 14 – Missile blast sites in comparison

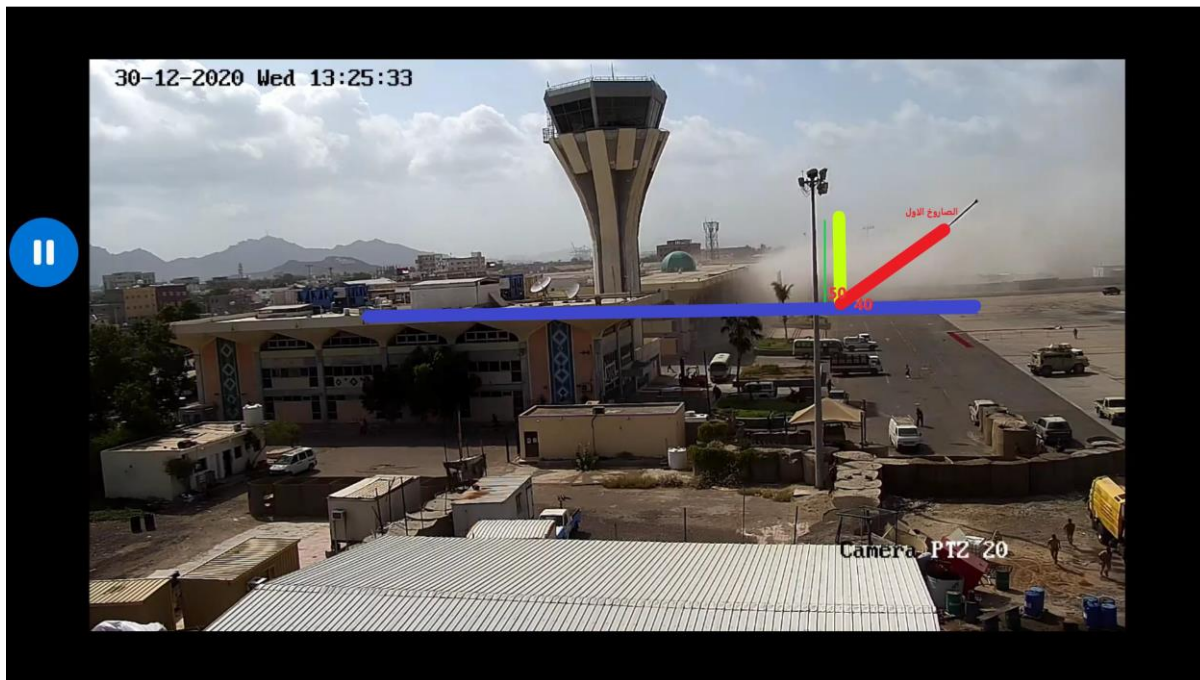
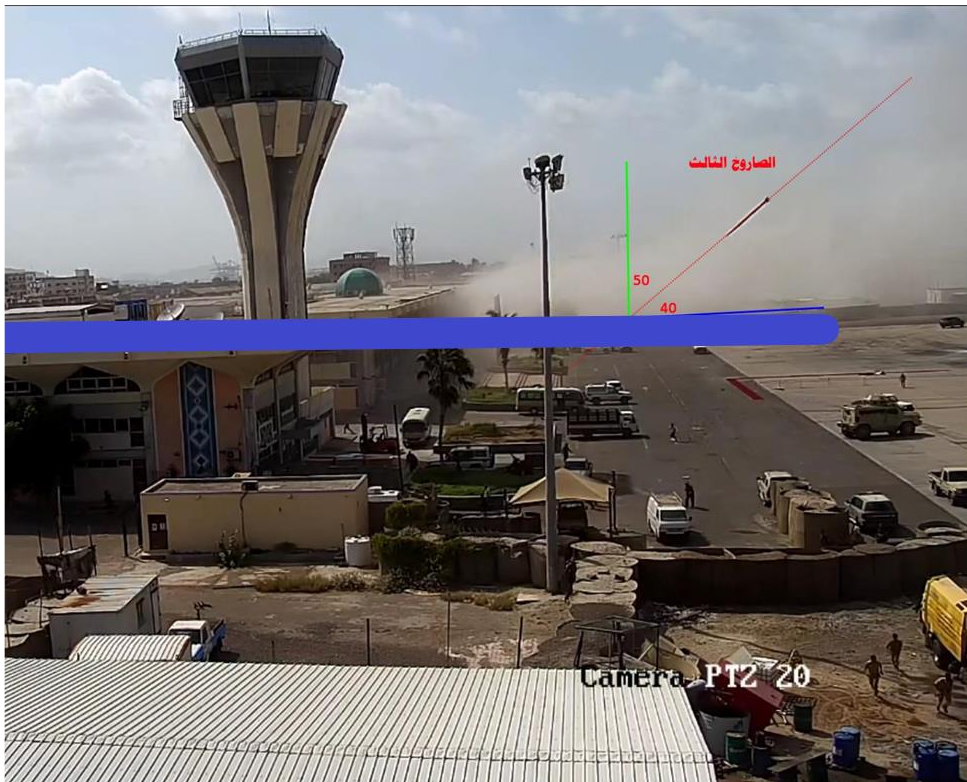
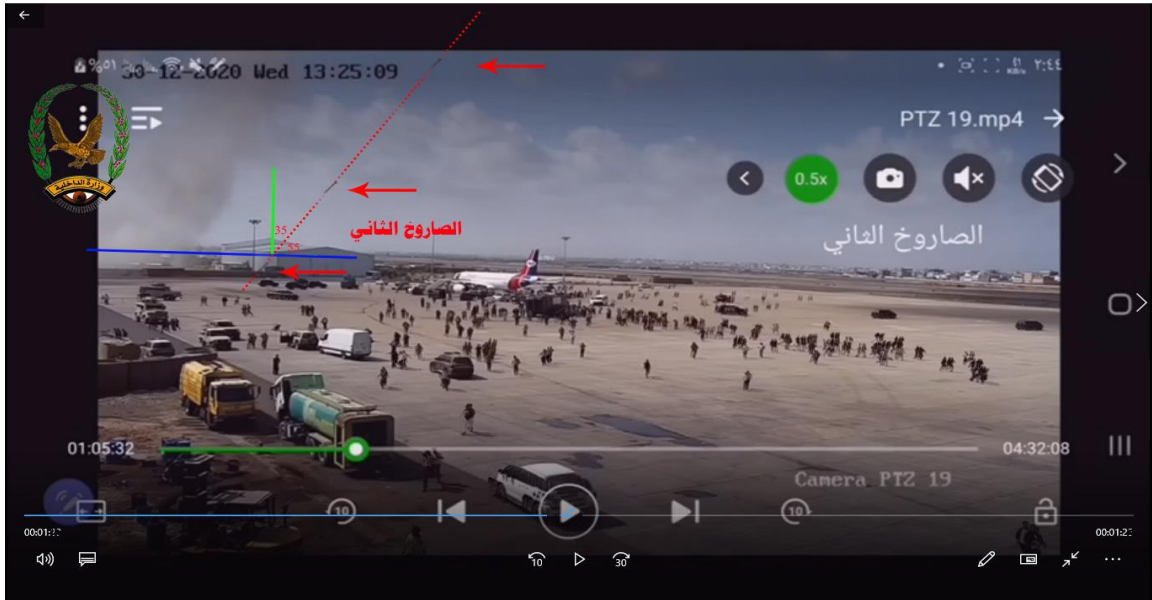
Image 15

- The first and third missiles entered at the same angle and were parallel. Their impact sites were some 15 metres apart, with a 40-degree angle and a 50-degree impact angle. The second missile followed a trajectory close to the impact sites of the first and third missiles, with a 35-degree angle and a 55-degree impact angle; see images 15, 16 and 17.
- The three missiles entered from the north and slightly to the west.
