SRI LANKA

Post-Tsunami Environmental Assessment

**United Nations Environment Programme
and
Ministry of Environment & Natural Resources of Sri Lanka**

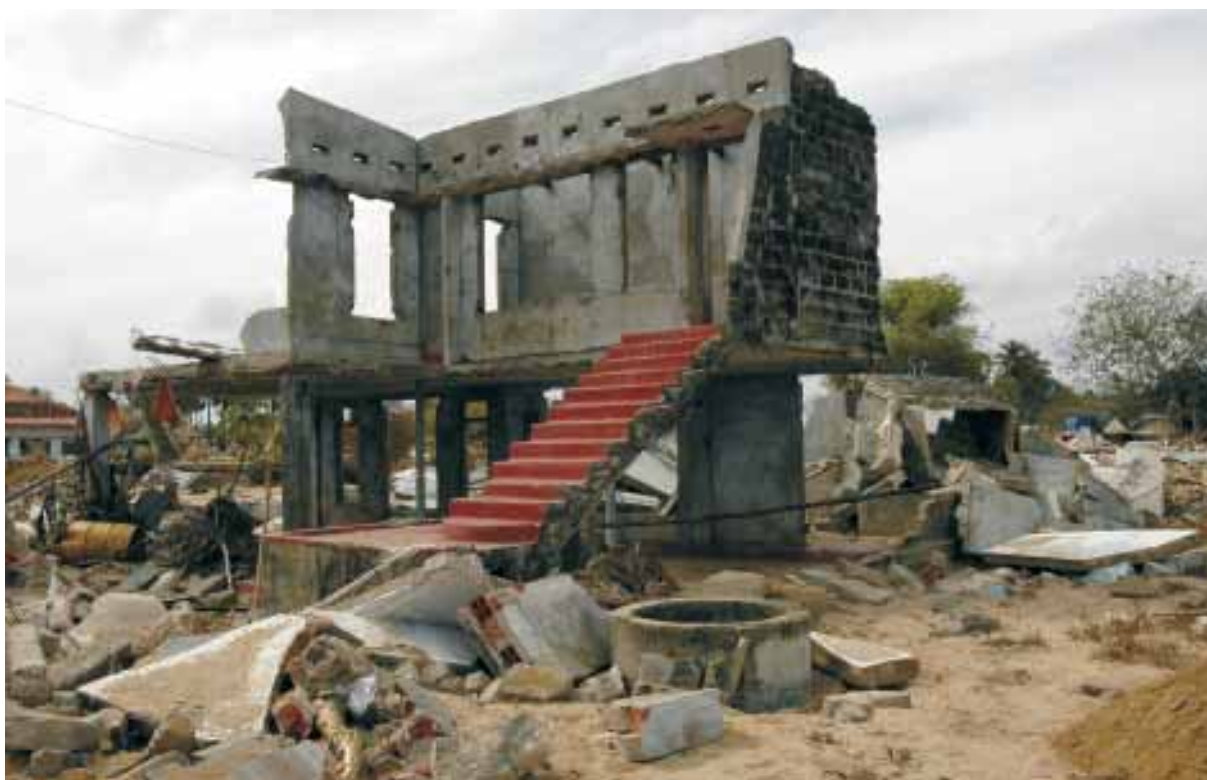
Most houses in Kilinochchi in northern Sri Lanka were completely destroyed by the tsunami. © Shehzad Noorani/Still Pictures

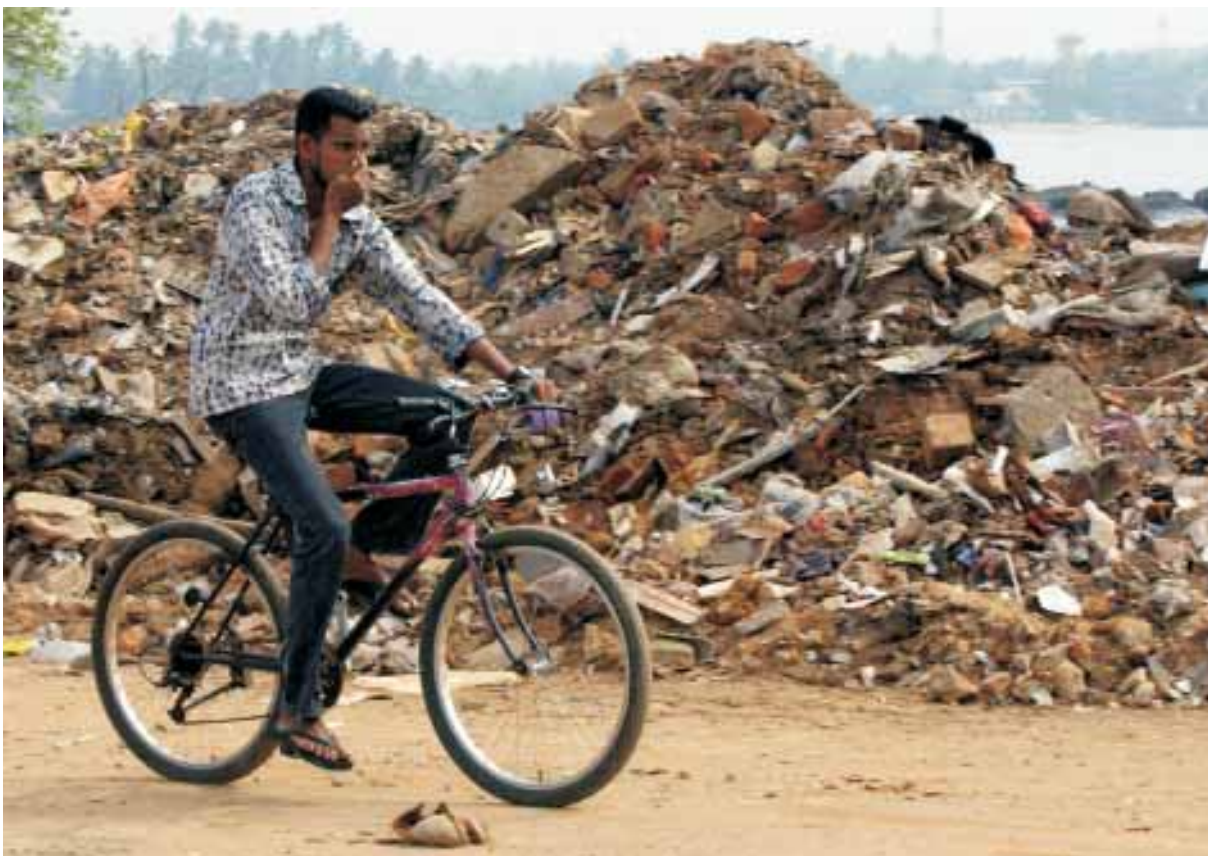
Piles of debris in Galle giving out a terrible smell of decomposition. © Indranil Mukkerjee/AFP/Getty Images

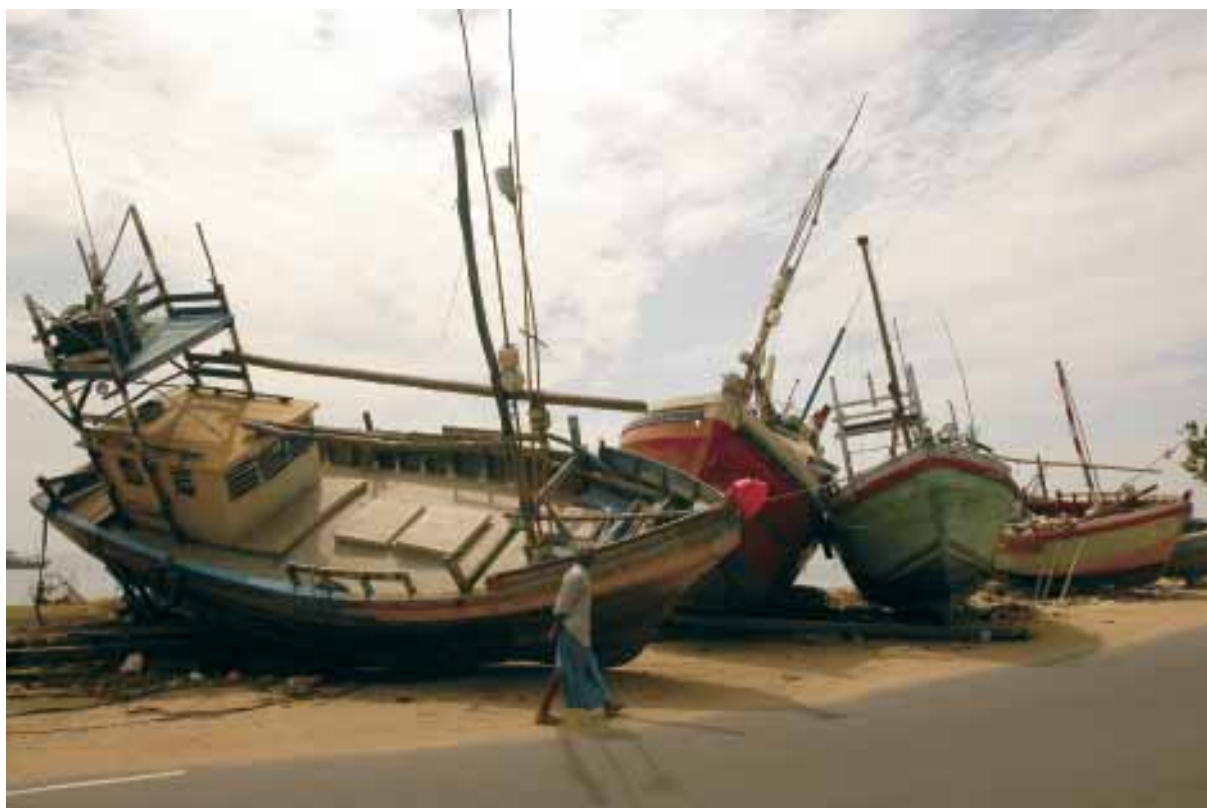
At Galle, in southern Sri Lanka, the tsunami threw most fishing boats hundreds of metres inland on the main road and into residential areas, causing great damage. ©Shehzad Noorani/Still Pictures
