S/23505
30 January 1992

REPORT ON THE NINTH IAEA ON-SITE INSPECTION IN IRAQ

UNDER SECURITY COUNCIL RESOLUTION 687 (1991)

11 - 14 January 1992

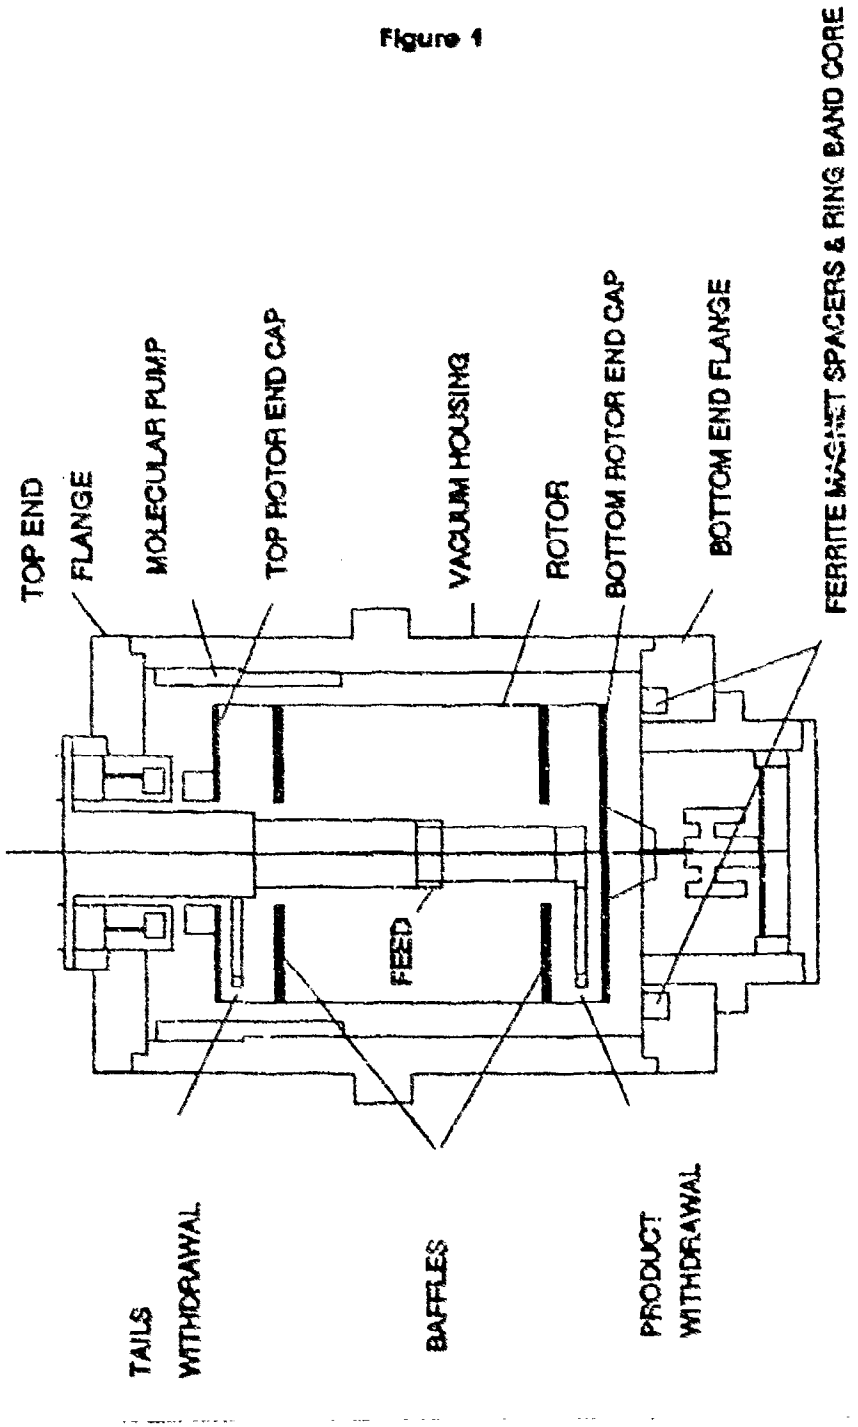
Figure 1

A schematic showing the various centrifuge components referred to above is presented as Figure 1. The estimate of the numbers of centrifuge components that could have been manufactured from the stated amounts of material implies no

FIGURE 1. CENTRIFUGE COMPONENTS

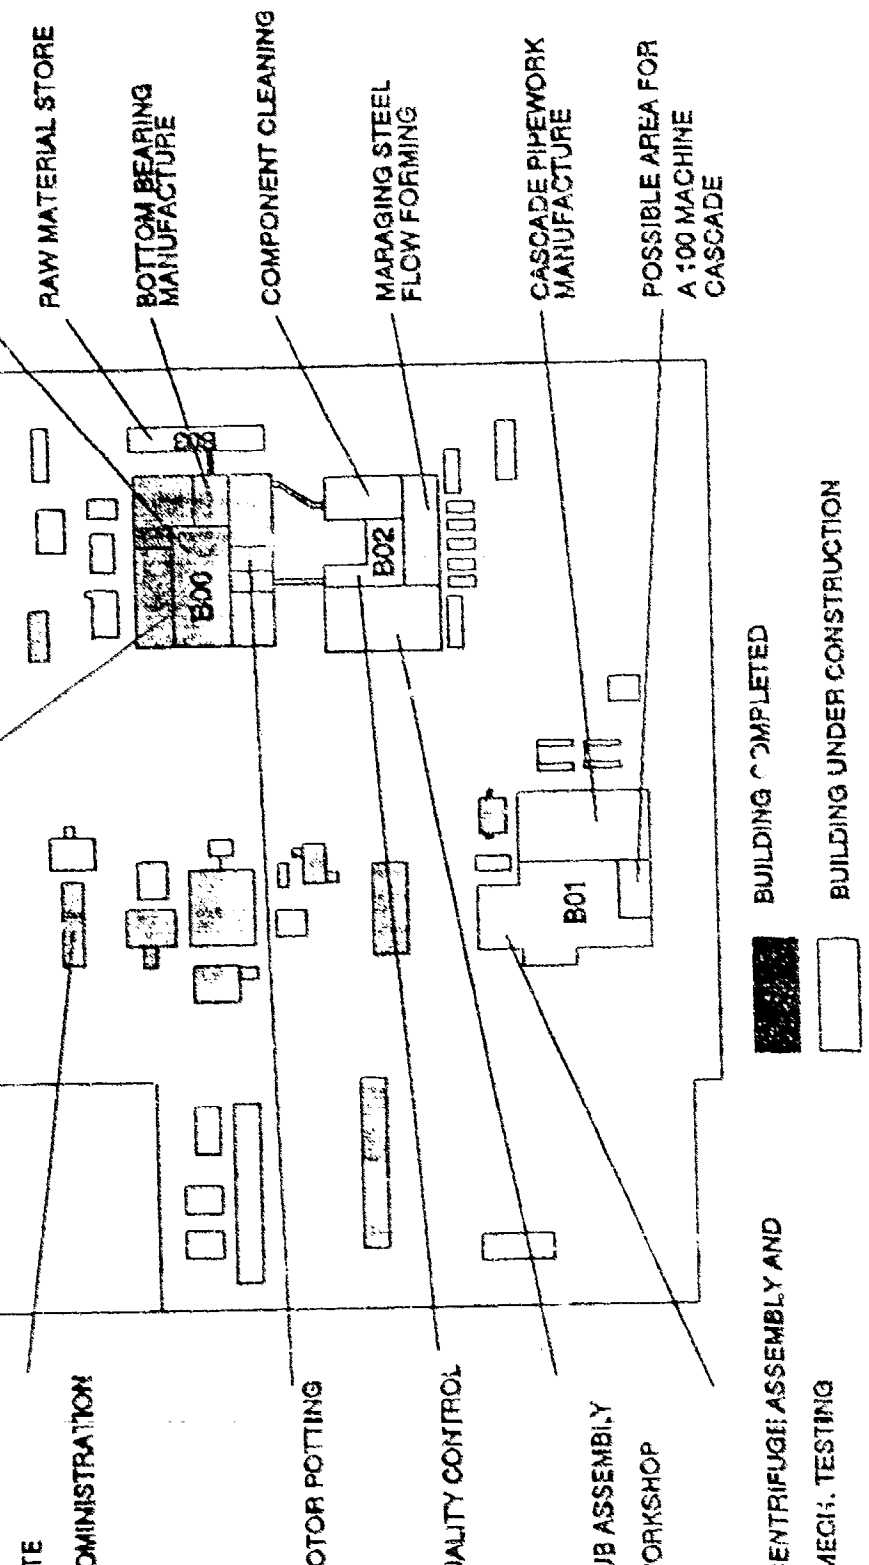
Figure 2

15. The additional five CNC machines referred to in para. 13 above, which are now stated to have been intended for installation at Al Furat, provides a larger potential production capacity than originally estimated by experts. The layout of the Al Furat complex with the planned utilization (as identified by Iraq) is described in Figure 2. The buildings designated as B01, B02 and B03 were far from completion when work stopped.

FIGURE 2. THE AL FURAT CENTRIFUGE PRODUCTION COMPLEX
