United Nations  
Department for Humanitarian Affairs  
DHA Geneva

# Landslide *La Josefina* on the Paute River, Cuenca, Ecuador

## Report on Disaster Management (English Version of the Consultancy Report)

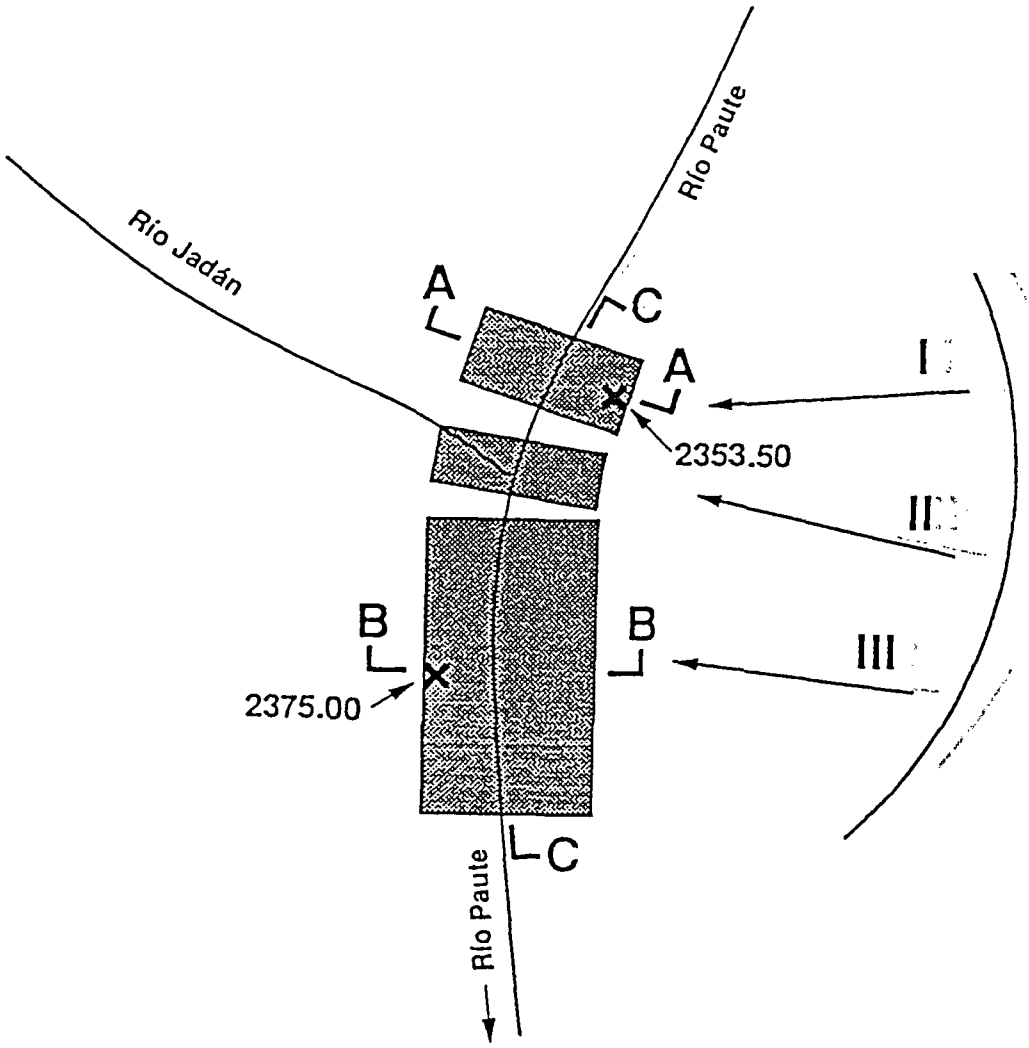
Figure 2: La Josefina Landslide  
Stages of the Landslide

The stages of the landslide are shown in Figure 2.

The order given above may have been different, since visibility was such that it was impossible for anyone to observe the phenomenon. What is stated is only what emerged from the verbal statements of survivors. The geology of the landslide is shown in Figure 3. The Military Geographic Institute (IGM) quickly overflew the area of the landslide and was thus able to rely on a 1:2,000 aerial photographic survey of the area of the embankment. Water immediately began to collect upstream from the embankment created by the landslide, forming two pools, the levels of which rose rapidly. On 3 April, the water level in the River Paute reached 2,329.00 m above sea level, whereas the original level of the river in the area of the landslide had been no more than 2,300.00 to 2,310.00 m above sea level, as may be verified from maps on a scale of 1:10,000 that were in existence before the landslide.

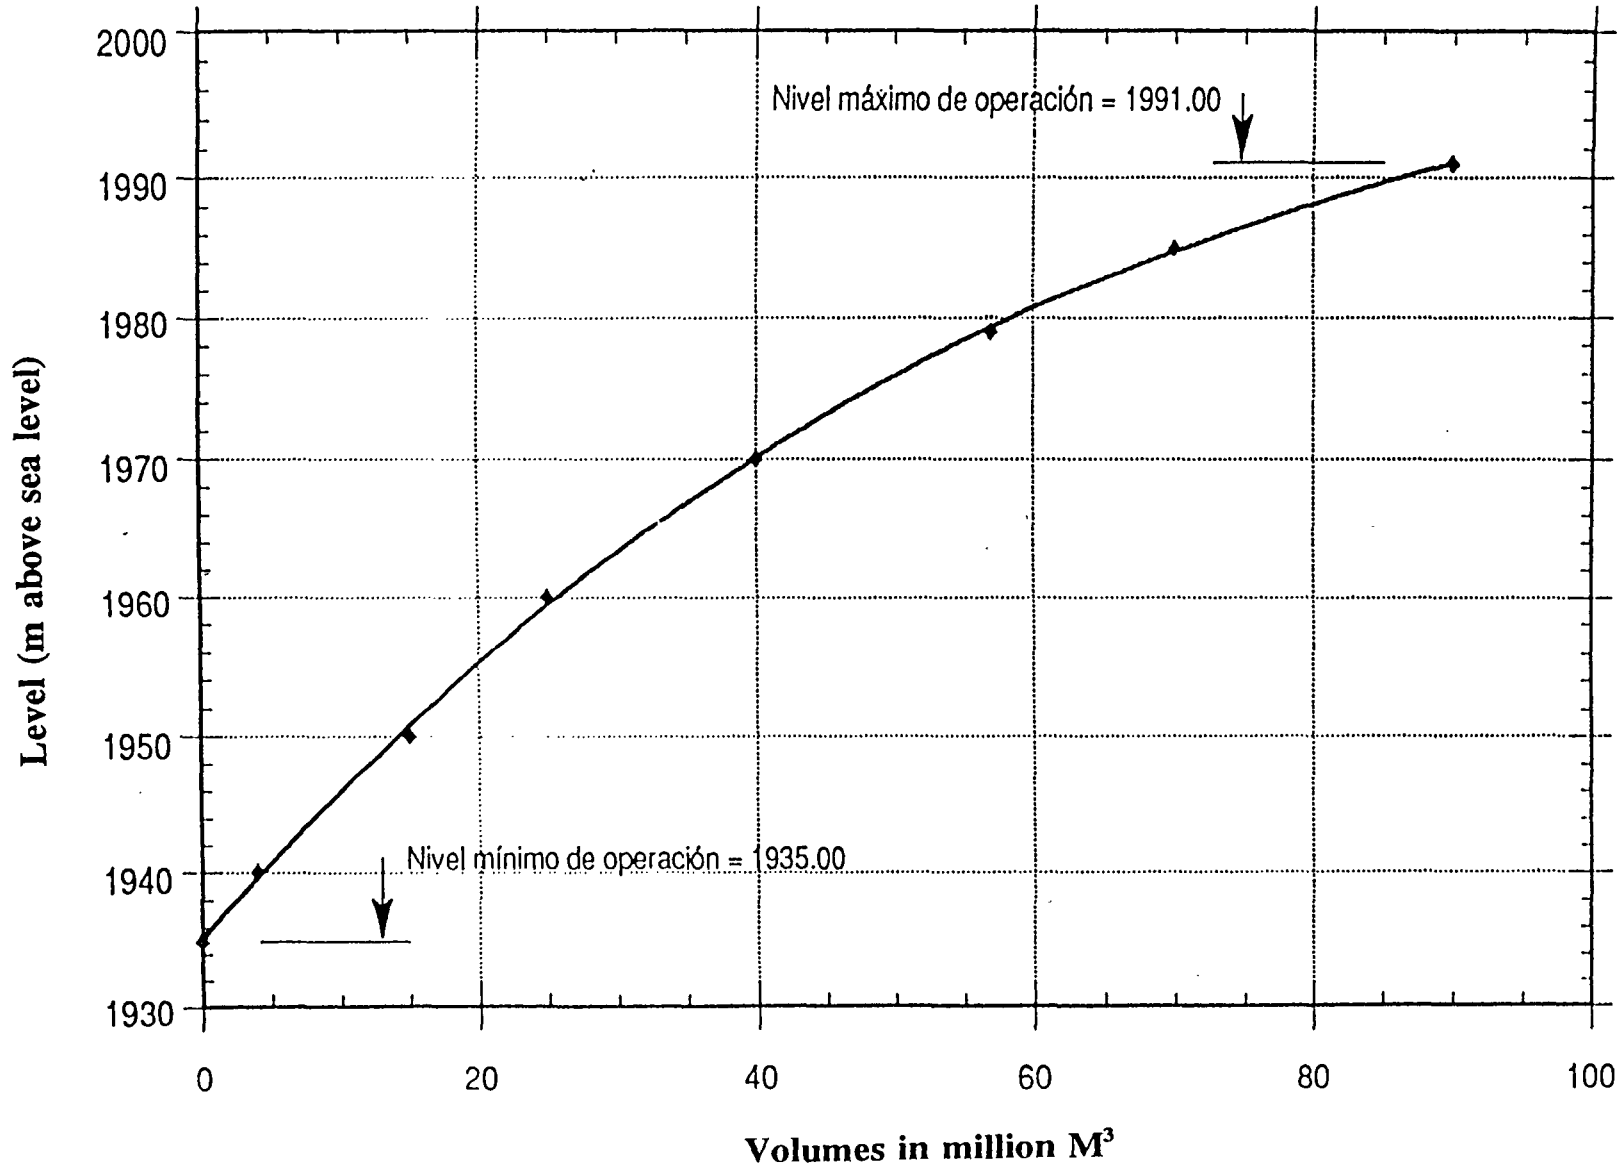
Figure 12: Volumes of the Amaluza Reservoir

The Amaluza arch-gravity dam came into operation in 1983. The total volume of water stored in the reservoir, which is some 20 km long is 120 million m<sup>3</sup>, whilst the active volume is only 90 million m<sup>3</sup>. The maximum and minimum operating levels are respectively 1,991.00 m and 1,935.00 m above sea level. Since 1983, the spillways have evacuated only discharges less than 1,500 m<sup>3</sup>/s. A curve of volumes of the Amaluza Reservoir is shown in Figure 12. Water profiles down the Josefina Landslide are given in Figure 13.

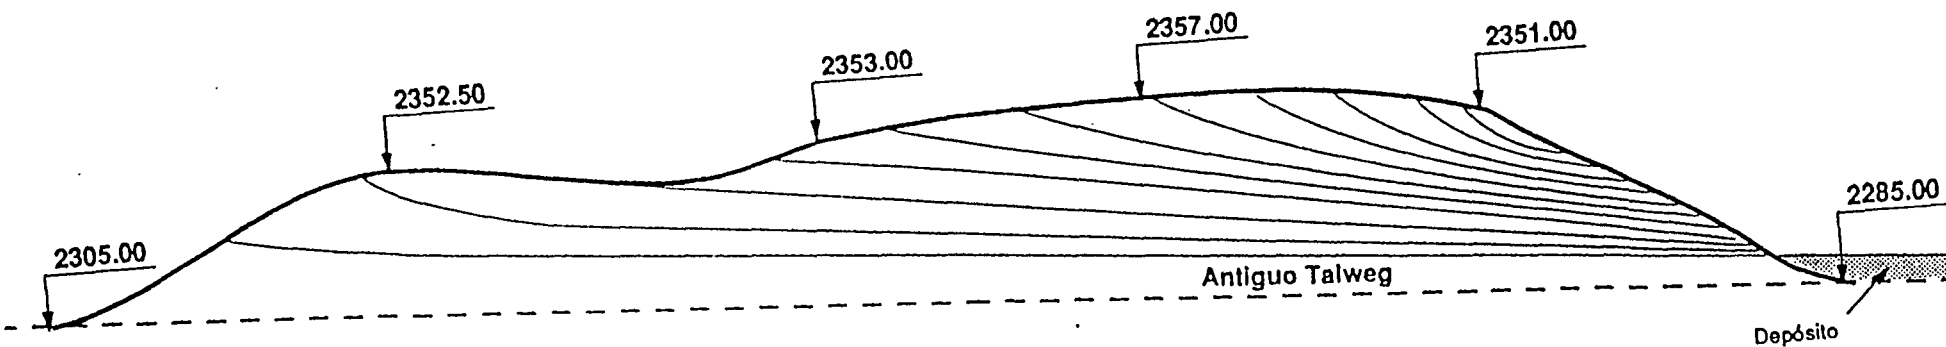
Figure 16: La Josefina Landslide  
Erosion Process

It was not until during the night of 30 April to 1 May 1993 that the retrogressive erosion reached the entrance to the canal, but this could not be seen because of the darkness. An abrupt increase in discharge downstream from the La Josefina embankment, which signified that retrogressive erosion had finally reached the entrance to the drainage canal, was reported at approximately 6 a.m. on 1 May. Assessed discharges can be seen in Figure 14. A longitudinal section of the drainage canal in the process of the erosion is given in Figure 16.

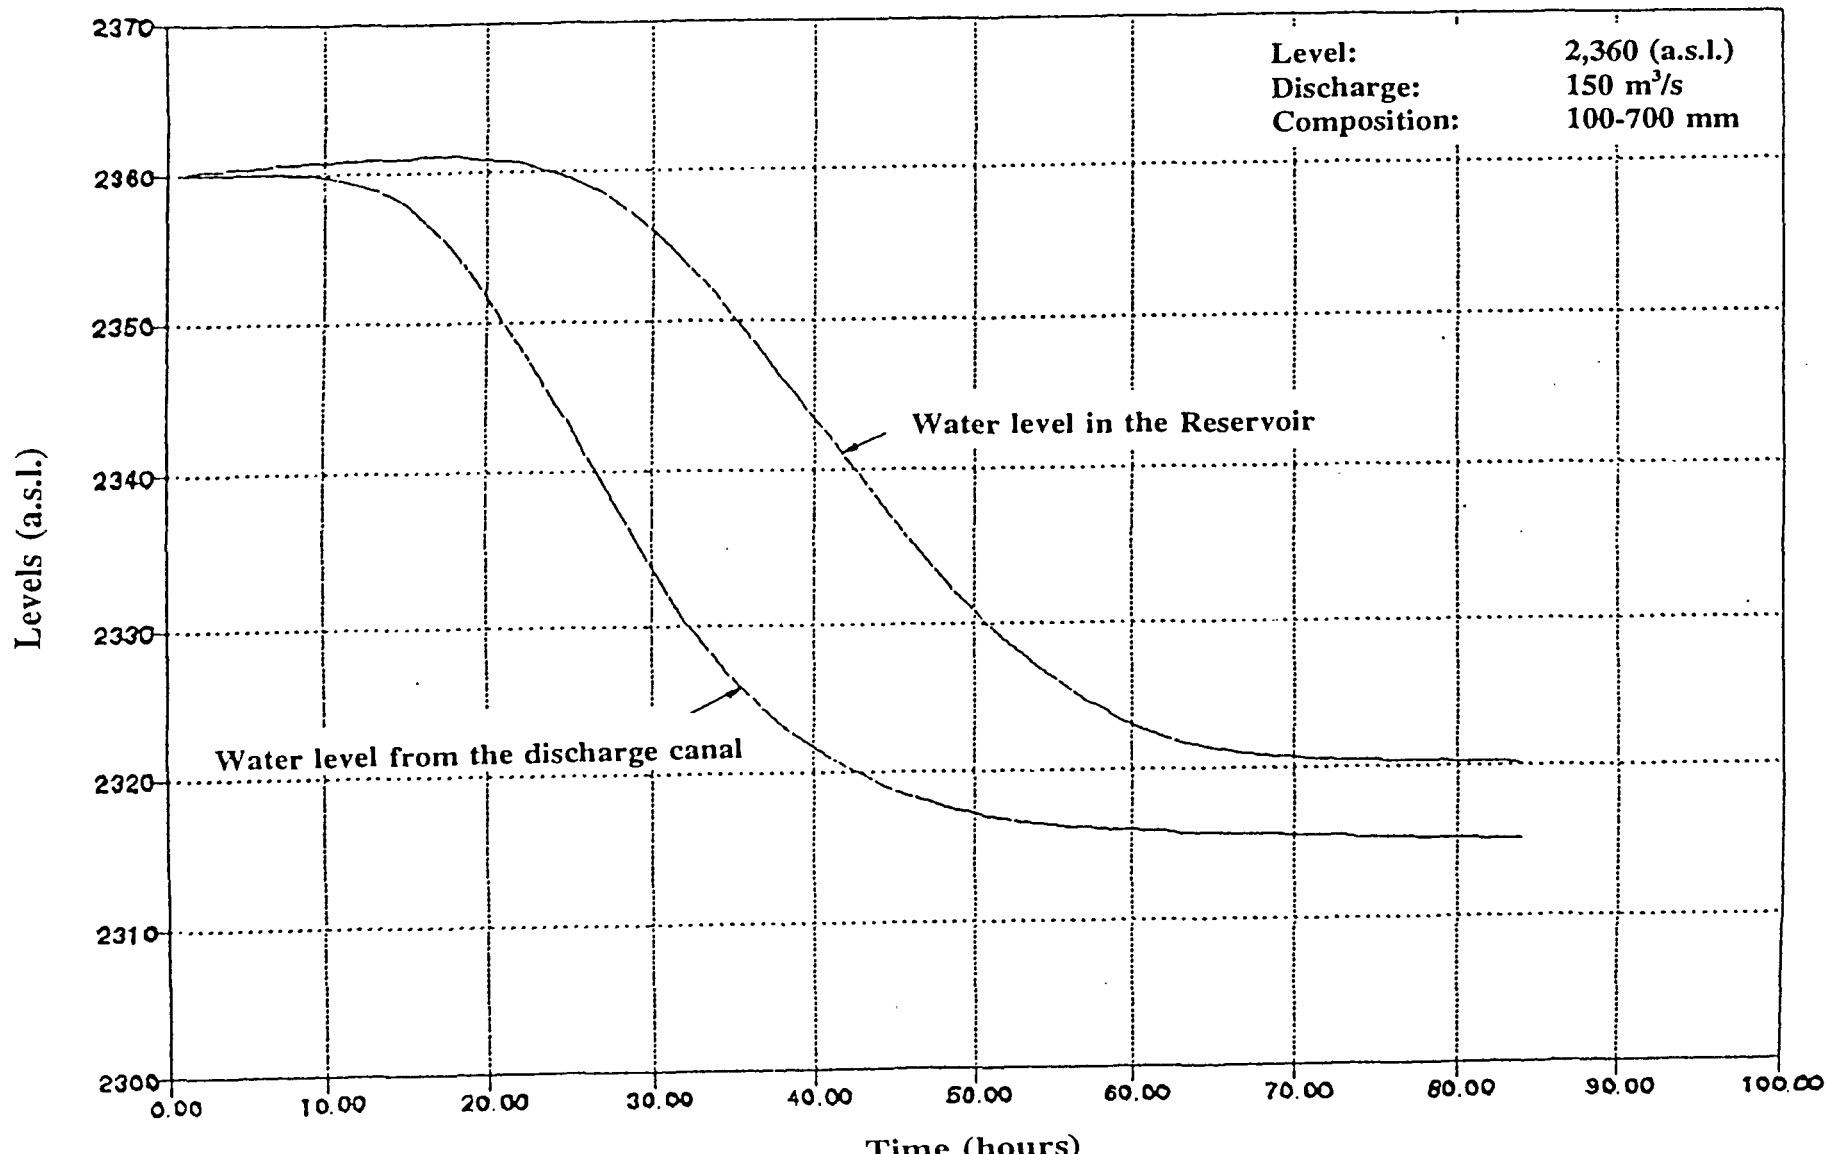
Figure 17: Simulation Exercise  
Modelling Canal Erosion  
Situation 1

Several models of the erosion of the landslide body and the flow-rates of the outpouring water were worked out. Examples of these are presented in Figures 17, 18 and 19. Cases were simulated, with the results dependent first and foremost on the particle-size composition, but also on the level (and the volume) of the dammed-up water and on the rate of inflow when the water overflowed.
