ECE/TRANS/WP.29/GRSG/2006/23
28 July 2006

COMMENTS BY THE EUROPEAN COMMISSION EXPLAINING ITS POSITION
CONCERNING THE USE OF A PICTOGRAM TO IDENTIFY EMERGENCY EXITS
IN REGULATION No. 107

(M₂ and M₃ vehicles)

Submitted by the expert from the European Commission (EC)

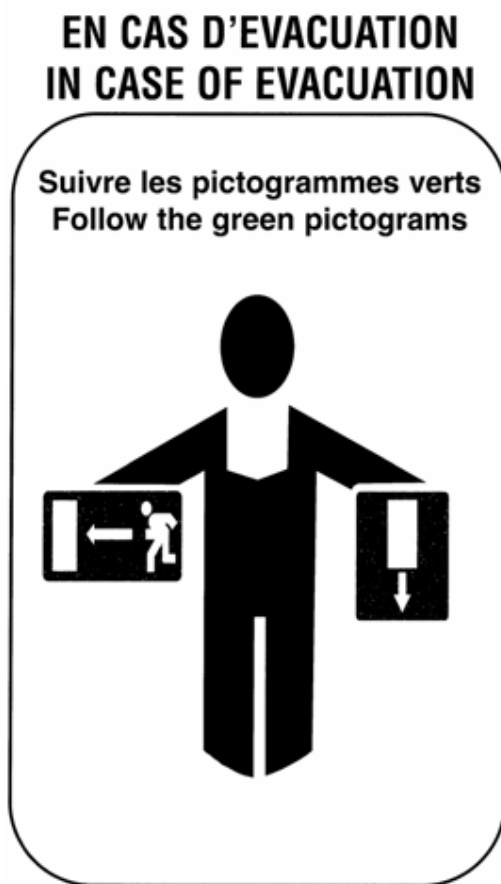
Figure 1

More commonly, the pictograms referred to in paragraph 3.4. of Annex II of Directive 92/58/EEC are used in corridors in public buildings to show the route to find exits. At the exit itself (or in the front of the exit), another pictogram - a rectangle plus an arrow- is used (see Figure 1).

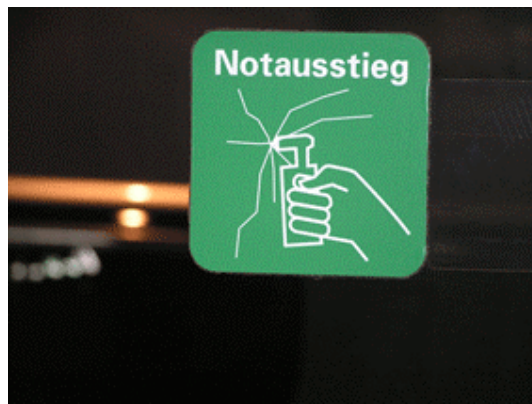
Figure 2

It has to be pointed out that some manufacturers use other pictograms on emergency windows which could probably serve as a reference (see Figure 2). Therefore, the EC believes that ISO relevant committee should be invited to consider this issue.
